Division of Drinking Water

October 30, 2017

2017 SANITARY SURVEY FINDINGS Palo Alto Park Mutual Water Company, Water System No. 4110020

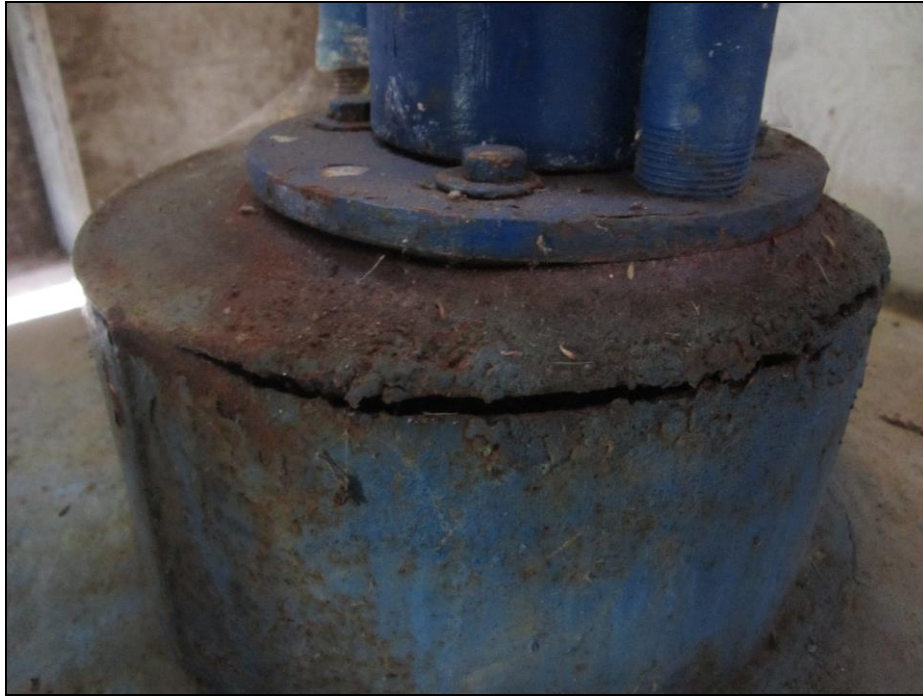
The above ground features of Wells 02, 05 and 07 are also in poor condition. As seen in figure 1, the well casing of Well 02 has cracked away from the top flange, creating a pathway for contaminants to reach the water supply. Please take immediate actions to seal the opening to prevent the entrance of animals or other sanitary hazards. In addition, please also evaluate the structural integrity of the well casing and make necessary corrections before the well catastrophically fails.

Figure 1. Well 2 – Opening between well casing and top flange.

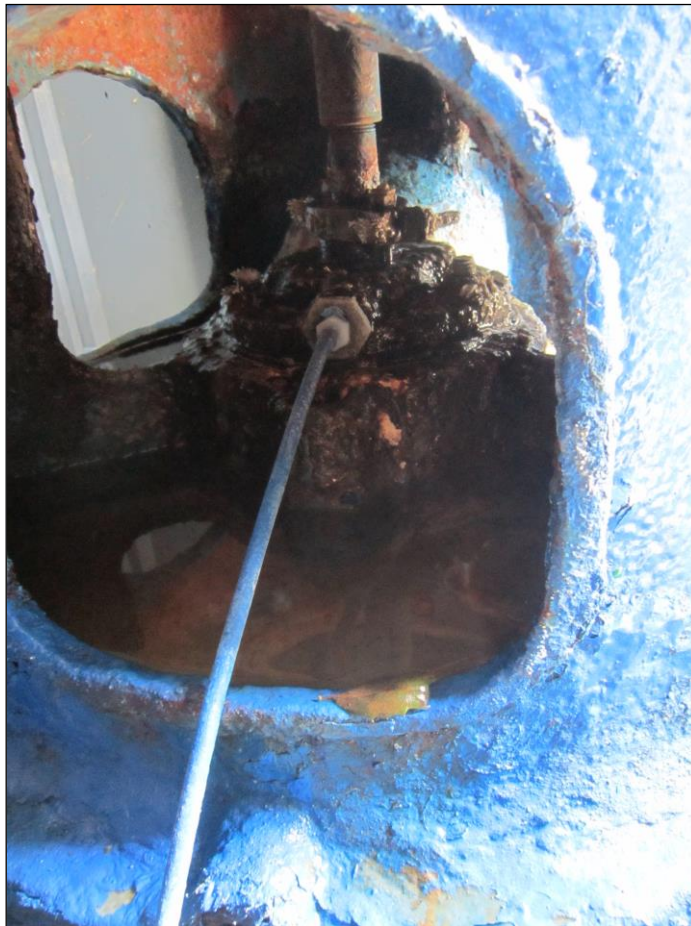
As seen in figures 2 (Well 5) and 3 (Well 7), various above ground components of Wells 05 and 07 are beginning to rust. Please explore options to correct the problem.

Figure 2. Well 5 – Rust on above ground features.

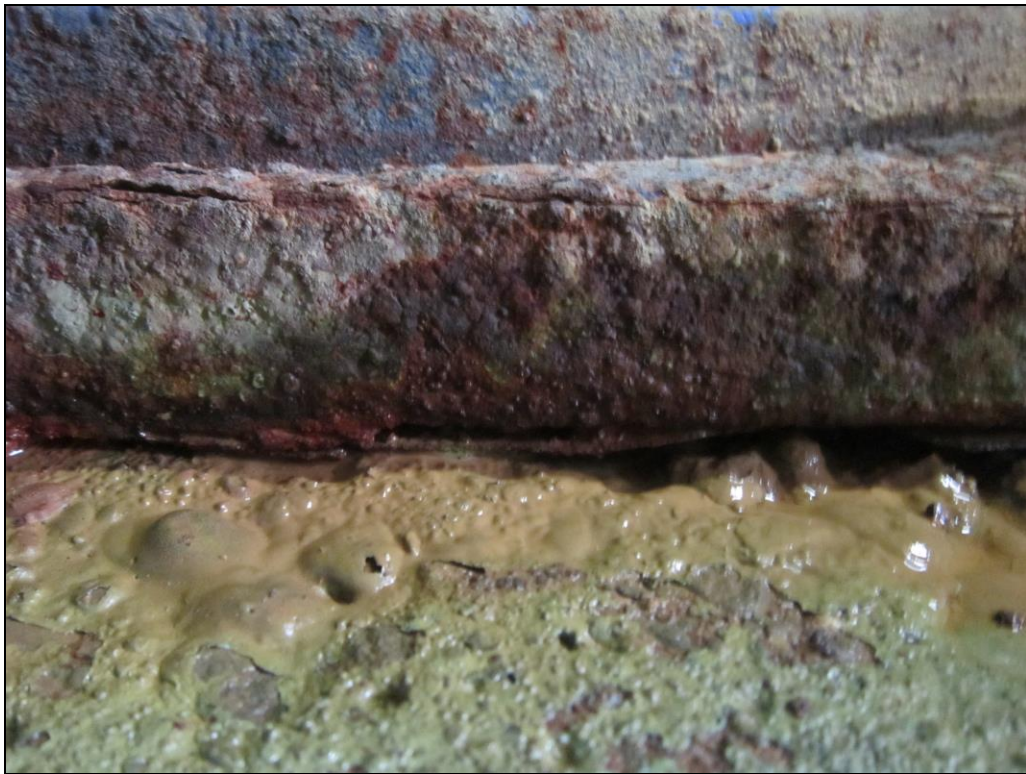
Figure 3. Well 7 – Rust on above ground features.

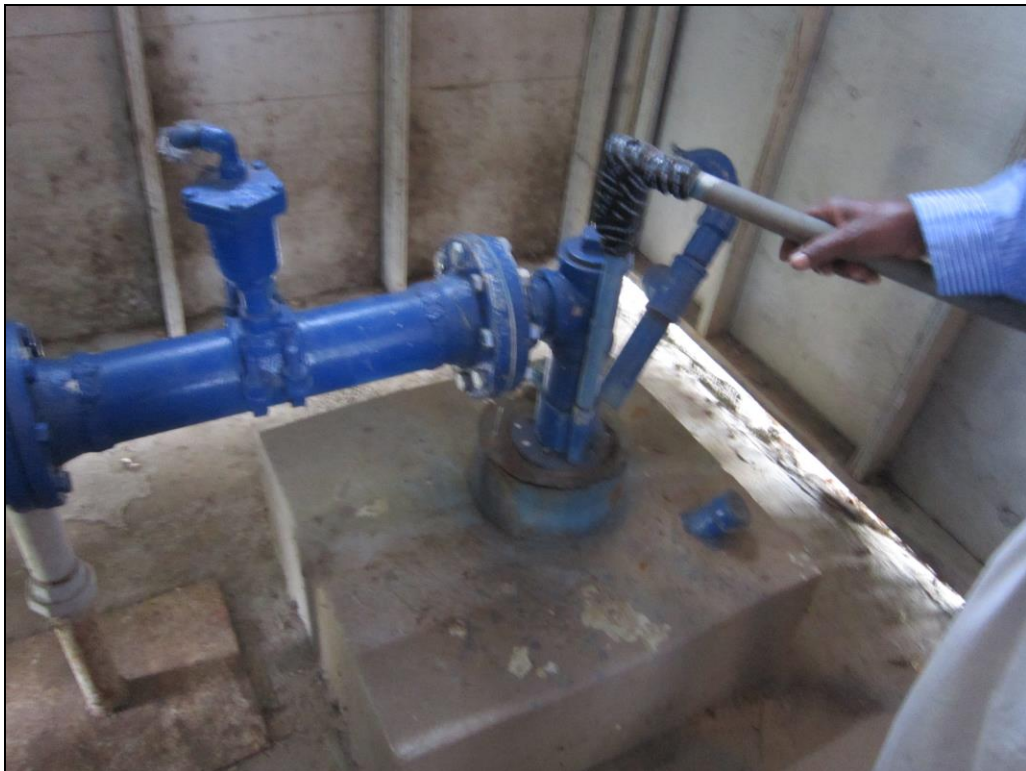
Groundwater supply wells should be well protect against rodents or other animals. The building structure around Well 02 have separated from the concrete slab, creating an opening at the base of the building (figure 4). The screens on several of the building structures have come loose or fallen off (figure 5). Please secure the buildings to prevent animals from gaining access to the well site.

Figure 4. Well 2 - Opening beneath building structure.

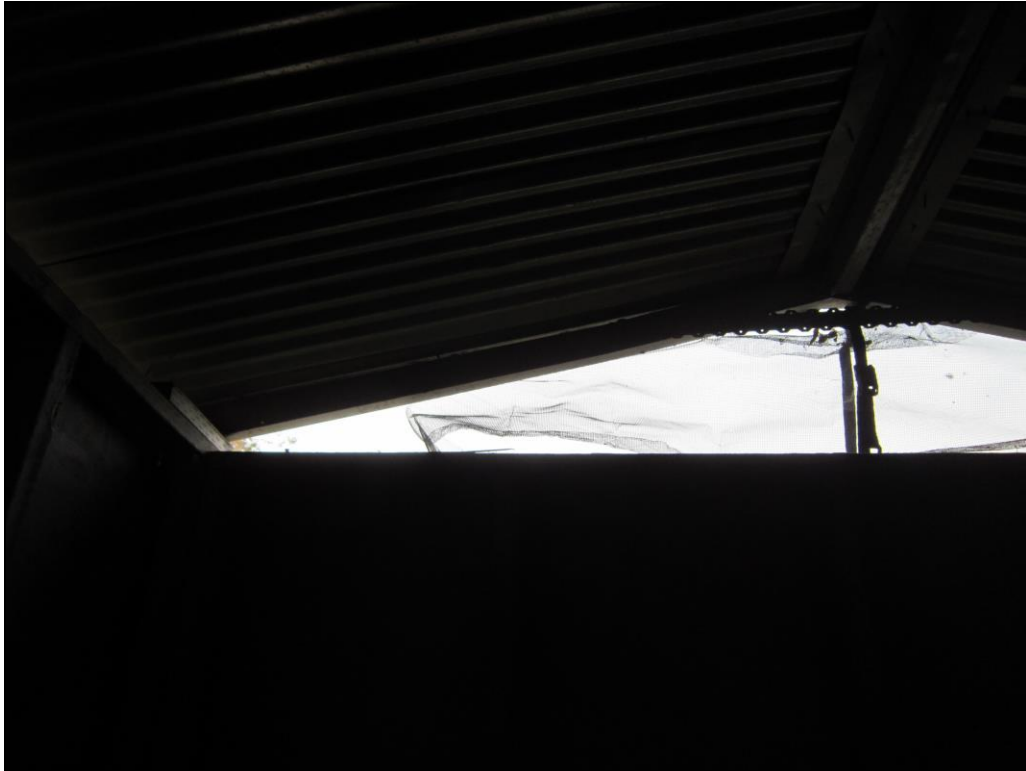
Figure 5. Loose screens on well building structures.

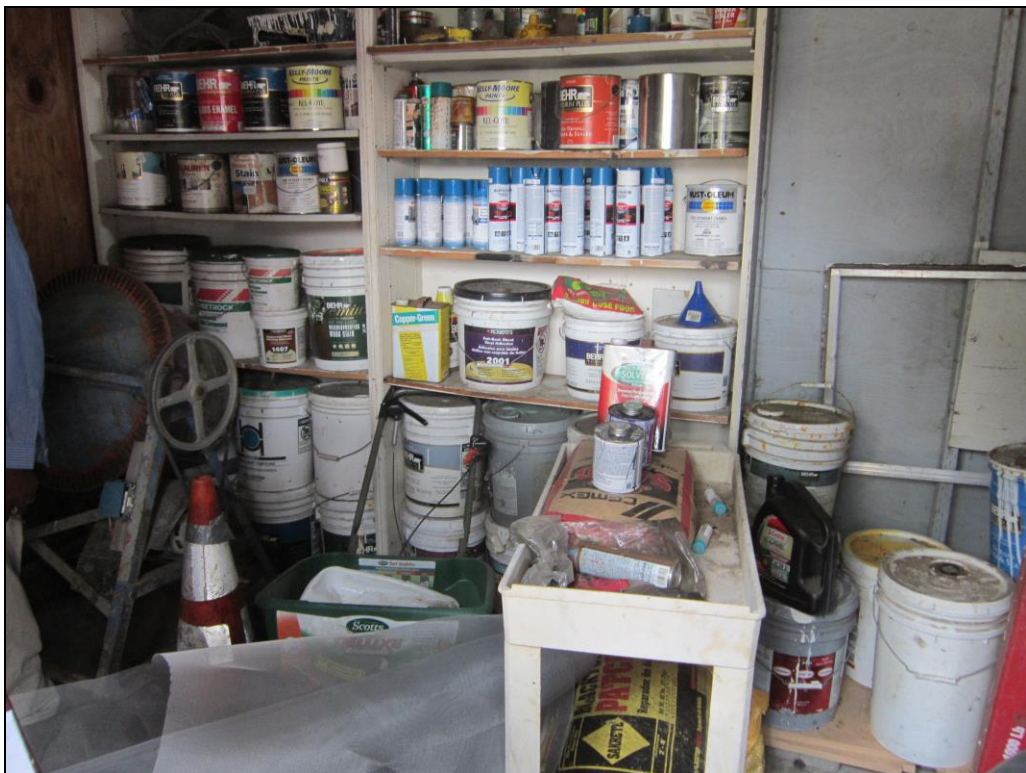
In addition, chemicals, paint or other solvents should not be stored next to a well site (figure 6). Please immediately remove these containers to prevent contamination of the ground water supply.

Figure 6. Well 3 – Chemicals stored next to well site.
