# **PALO ALTO PARK MUTUAL WATER COMPANY**

**Response to: 2017 Sanitary Survey Findings to items due 30 November 2017 and to immediate Actions**

#### **ABOVE GROUND CONDITION OF WELLS 02, 05 AND 07/ WELL BUILDING STRUCTURES**

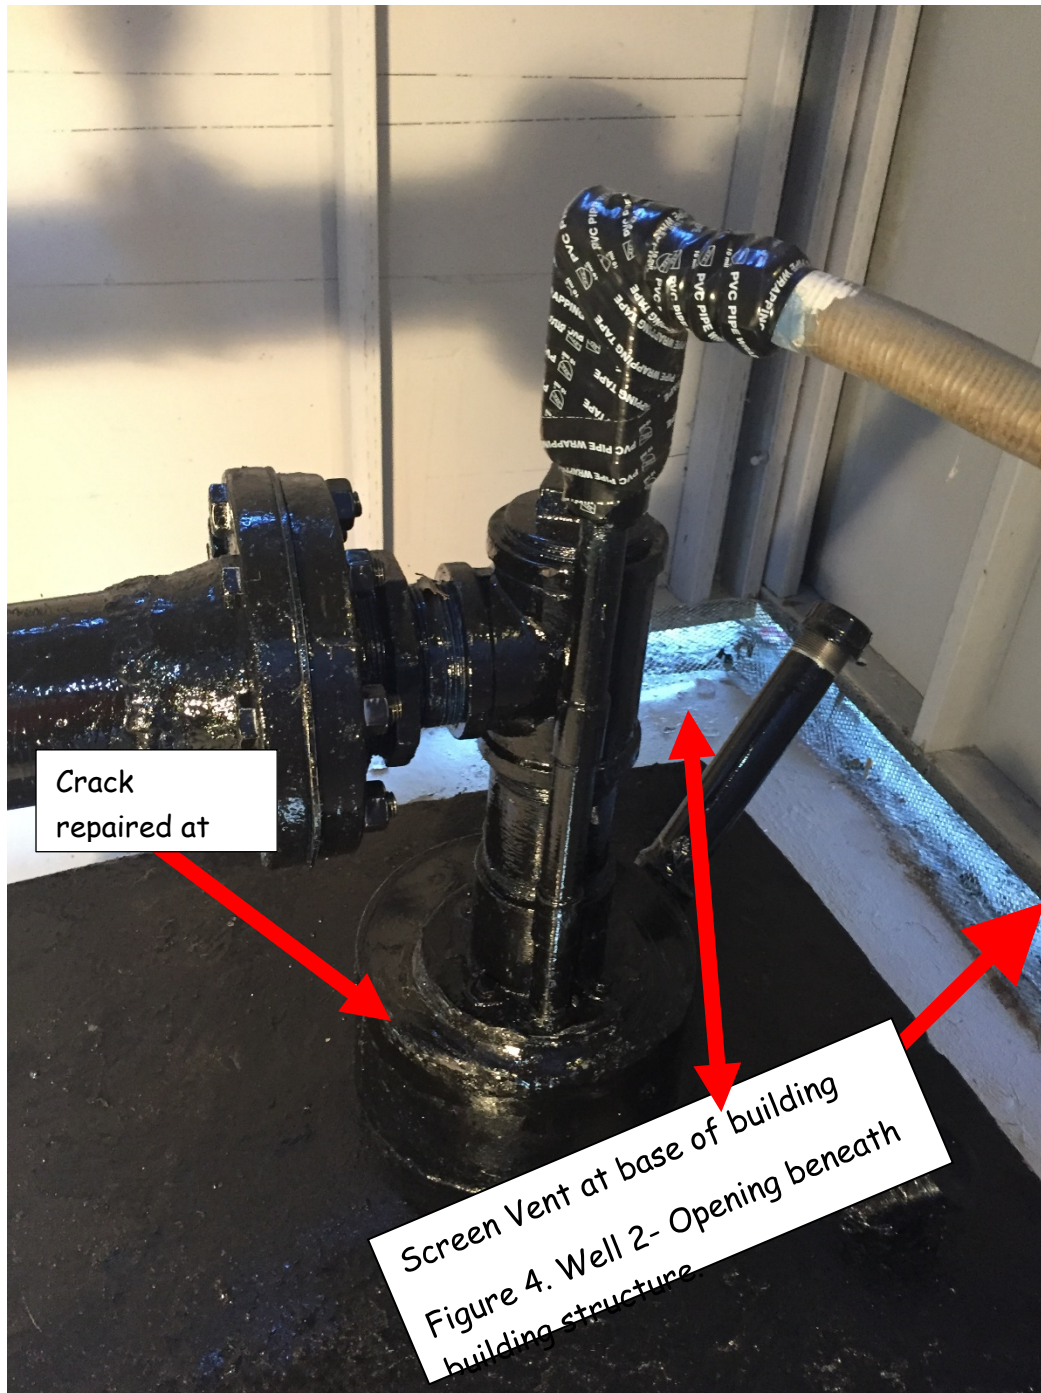
The above ground features of Wells 02, 05 and 07 are also in poor condition. As seen in figure 1, the well casing of Well 02 has cracked away from the top flange, creating a pathway for contaminants to reach the water supply. Please take immediate actions to seal the opening to prevent the entrance of animals or other sanitary hazards. In addition, please also evaluate the structural integrity of the well casing and make necessary corrections before the well catastrophically fails.

Well Number 2: per Figure 1. Well 2 Opening between Well Casing and top flanges.

Please see the attached photos of repairs to Wells 02, 05 and 07. We had the cracked that was at the flange on Well number two (2) welded closed. We also replaced venting screen at the top of the building and the bottom of the building we screened from both the inside and the outside. At Well number five (5) we replaced the venting screen at the top of the building. Well number seven (7) concrete grouted the area around petal of the base.

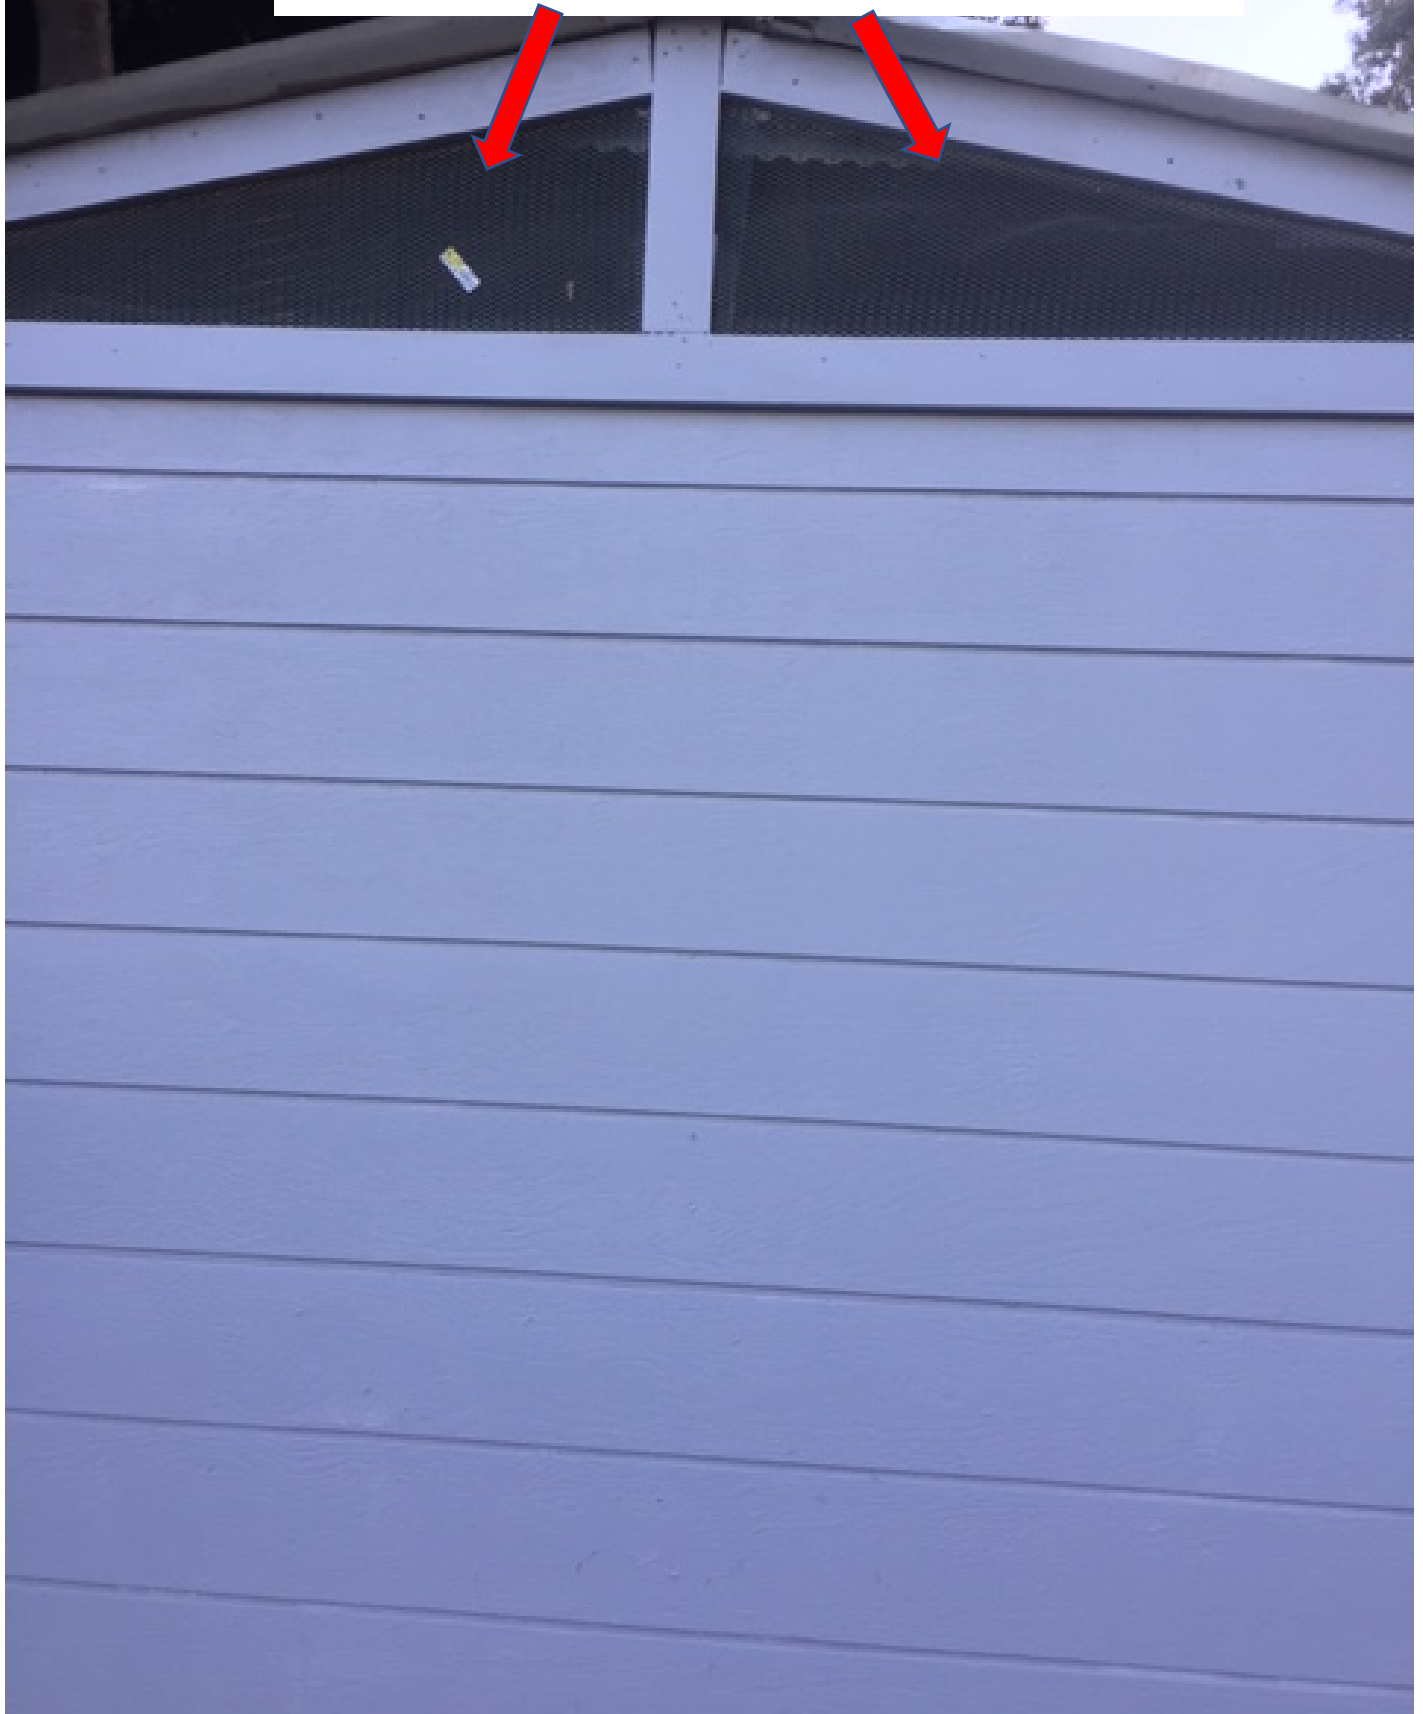
of the building (figure 4). The screens on several of the building structures have come loose or fallen off (figure 5). Please secure the buildings to prevent animals from gaining access to the well site. In addition, chemicals, paint or other solvents should not be stored next to a well site (figure 6). Please immediately remove these containers to prevent contamination of the ground water supply.

Intact screened vent Figure 5. Loose screens on well building structures. Well pump 2 top of building,

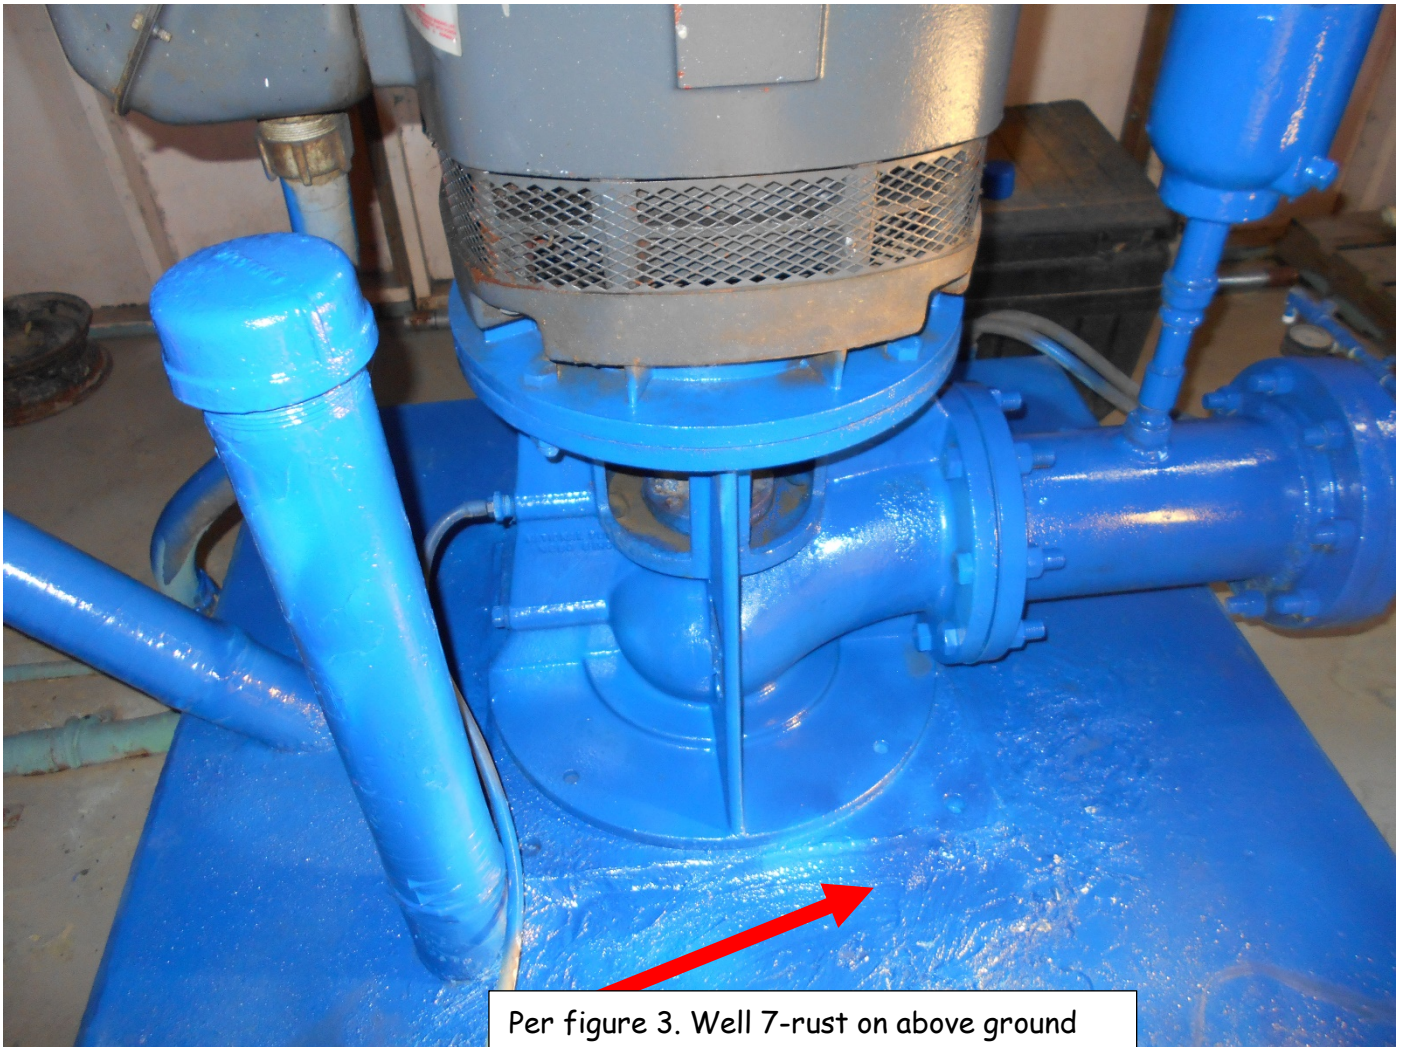
Per figure 3. Well 7-rust on above ground
