City of East Palo Alto

Investigation into Palo Alto Park Mutual Water Company

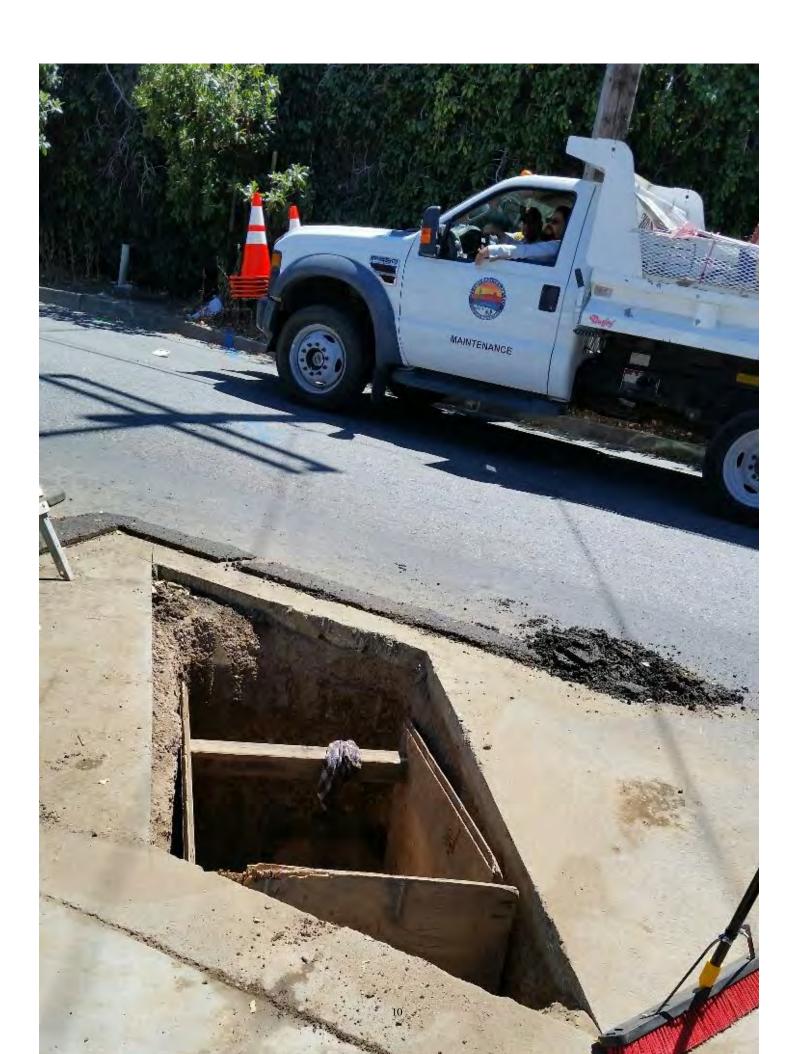
Location: Intersection of Poplar Avenue & East Bayshore Road (July 19, 2016) Witnesses: Lenin Melgar (Maintenance Division), Vicente Vazquez (Maintenance Division) & Kevin Lewis (Engineering Division) Picture 1 of 2

Picture 1 of 2	
Violations:	The previous picture depicts an excavation.
	This is consistent with a main repair
	 There are no markings from USA (811) around the excavation site
	 No encroachment permits were found in City records for this work
	 No inspections were conducted by City staff
	The replacement asphalt is not in accordance with City standards
	Worker caught in the excavation has been linked to other PAPMWC work in
	past encounters with City staff
	(see following witness narratives)

On July 19th 2016 I Lenin Melgar, along with Vicente Vazquez Maintenance workers for the City for East Palo Alto, were driving in a City vehicle on Poplar and East Bayshore in response to an illegal dumping complaint. We saw a work area that was not safe, no work ahead signs, no cones, very unsafe looking for such a large hole. We slowed down to see what was going on; simultaneously Kevin Lewis Public Works Inspector was arriving.

It was exposed water lines; I'm not sure if they were tapping into a main line or repairing one but was not safe at all. The guy was reluctant to talk and was stand offish. We offered our cones and our time to make the site safe. Kevin took over and we left the site.

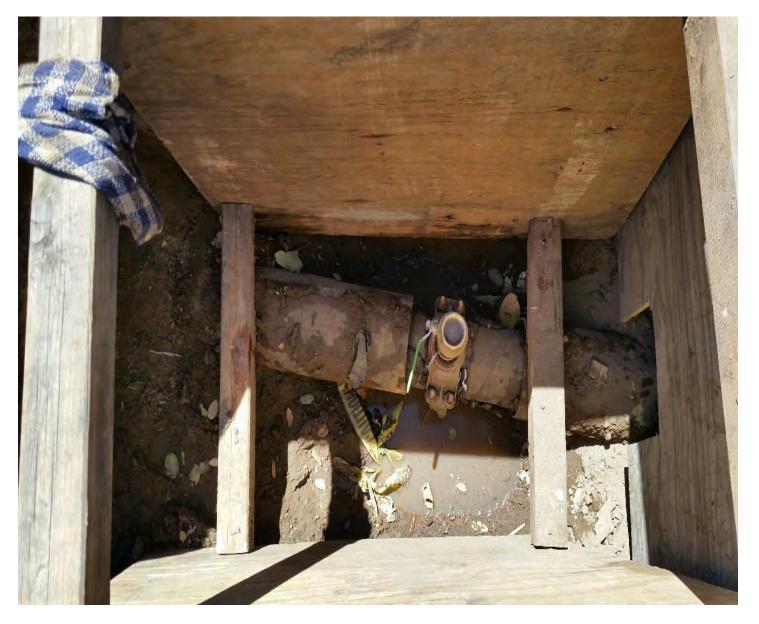
Location: Intersection of Poplar Avenue & East Bayshore Road (July 19, 2016)
Picture 2 of 2

Violations:	The above picture depicts an illegal excavation.
	Incorrect shoring
	 Tapping into water valve not belonging to PAPMWC
	Incorrect traffic control
	 Only one worker for this project, no flaggers
	Work without a City permit
	No inspections from City staff
	Water in excavation

Upon my arrival I noticed limited traffic control less of less than 15 ft. of either direction of the excavation. The limited traffic control pushed traffic into the opposite direction of oncoming traffic in both directions. I immediately placed cones available from my vehicle to correctly divert traffic as best I could. The lack of safety warranted a complete shutdown of the operation that was already in progress. In addition to no permit, no traffic control plan had been reviewed prior to my knowledge of this work excavation. The excavation was entered during afternoon peak traffic conditions. The size and magnitude of this excavation suggest that work began during the off hours of City Staff. This also suggests weekend preparation of USA Utility service locates leading into a following work week day of Monday evening of July 18th. During the day of July 18th the excavation did not exist during daily normal routine city observations.

I asked Earl the reason for drilling/tapping the water main. He stated that Palo Alto Park Mutual wanted to insert a television camera into the water main to search and view where the water main might be broken. I told Earl that he excavated over a water main which is owned by the City of East Palo Alto and operated by American Water Services. I stated that the main is not broken and that it had been turned off for reasons not at liberty to discuss. Earl commented that he had the correct water main and that they were not getting any water to the west side of the freeway. I asked him if he had a water distribution map showing the water utility grids of which he did not. I proceeded to show the worker where each water main is located and which water main does not belong to Palo Alto Park Mutual.

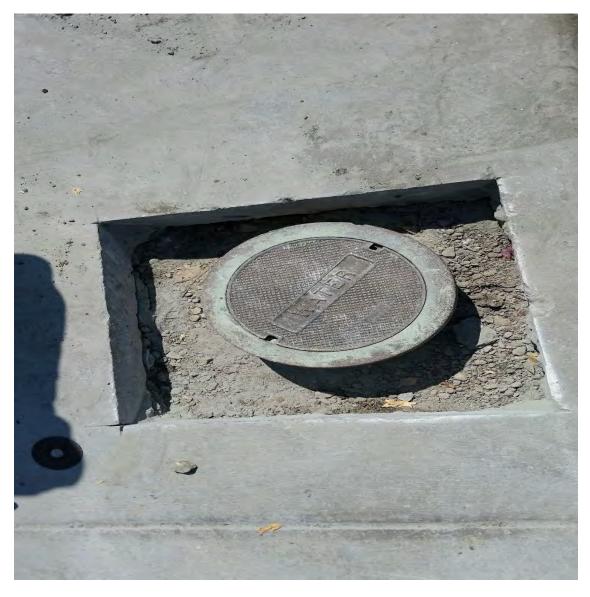
Location: Intersection of Poplar Avenue & East Bayshore Road (August 24, 2016)
Witnesses: Kevin Lewis (Engineering Division)
Picture 1 of 2

Violations:	The above picture depicts an attemped water valve excavation.
	This is consistent with a valve stem repair
	• There are no markings from USA (811) around the excavation site
	No encroachment permits were found in City records for this work
	No inspections were conducted by City staff
	The replacement cement is not in accordance with City Standards
	(see following witness narrative)

I observed Earl cutting a square portion of a new concrete gutter around what is known as a G5 Water Valve Box.

I asked Earl what repairs were being made and how come there was a concrete square cut and removed from the gutter. He stated that the "valve stem" which operates the gate valve to make it open and close was broken.

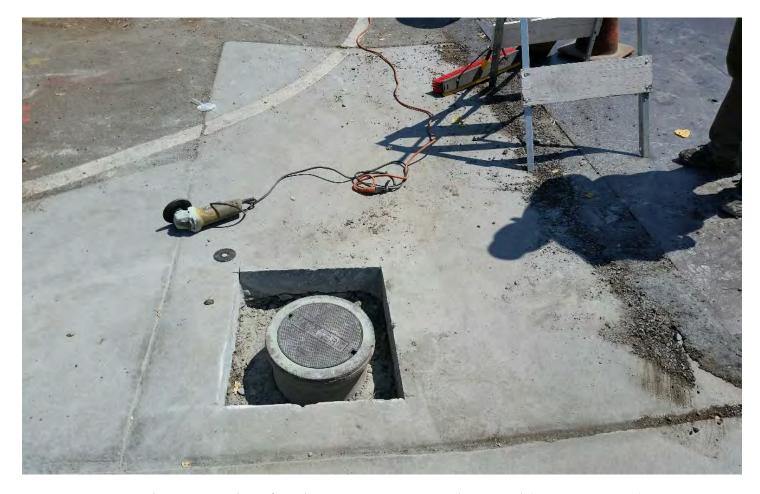
Location: Intersection of Poplar Avenue & East Bayshore Road (August 24, 2016)
Picture 2 of 2

Violations:	The above picture depicts an illegal excavation.
	This is consistent with a valve stem repair
	 There are no markings from USA (811) around the excavation site
	 No encroachment permits were found in City records for this work
	 No inspections were conducted by City staff
	The replacement asphalt is not in accordance with City standards

On the 26th of August, I found that only the immediate square area of concrete around the valve box was filled with concrete mortar (see exhibit F). Once the mortar settled and cured it left an unfinished rough path around valve the G5 Valve Box.

I requested that the concrete be replaced from seem to seem, meaning an entire square surrounding and past the valve box.

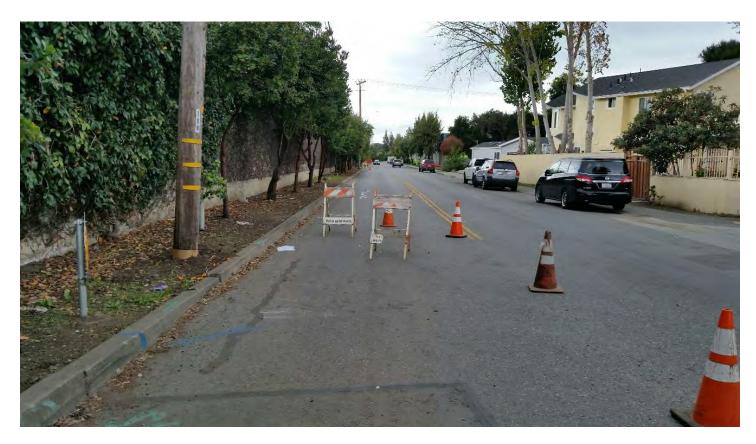
Location: Intersection of Poplar Avenue & East Bayshore Road (October 25, 2016)
Picture 3 of 3

Picture 3 01 3	
Violations:	The above picture depicts an improper traffic control for an illegal excavation.
	This is consistent with a main repair
	No encroachment permits were found in City records
	 No inspections were conducted by City staff
	The replacement asphalt is not in accordance with City standards
	 Incorrect traffic control for project
	No traffic control plan was submitted for review to the City

Within the excavation I observed an exposed 6 inch cast iron water main under repairs. Within my observation I noticed the excavation to be wet due to water leaking from the repair. Earl was in a crouched position, the work was observed to be deeper than 48 inches. The excavation was dangerous due to the side walls capable of caving in.

Due to my professional experiences the excavation was subject to vibration due to heavy traffic, thus East Bayshore traffic and the adjacent alignment to the U.S. 101 Freeway. I observed no shoring within the excavation to protect the worker from deteriorating sidewalls.

I asked Earl if he would install shoring on to the side walls of his excavation. He stated that he did not need any shoring. I asked him to exit the excavation and to return with shoring before reentering into the excavation. Earl exited the excavation and returned to the job site with improper materials such as pieces of lumber for his shoring.

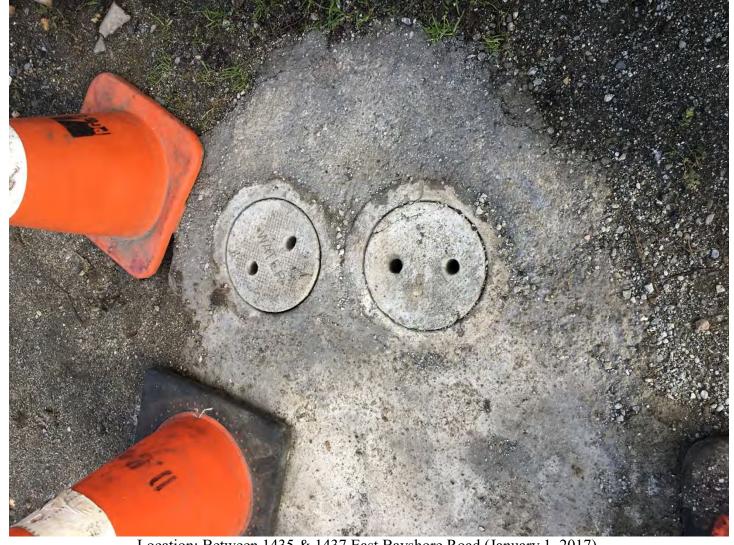
Location: Between 1435 & 1437 East Bayshore Road (January 1, 2017)
Witness: Kevin Lewis (Engineering Division)
Picture 1 of 4

Violations:	The above picture depicts an illegal excavation.
	This is consistent with a valve repair
	No encroachment permits were found in City records
	No inspections were conducted by City staff
	The replacement asphalt is not in accordance with City standards

I noticed an excavation that had already been in progress upon my arrival. As I proceeded to approach the excavation I noticed a PAPMWC employee "Earl" working near the excavated site. I asked Earl what he was working on. Earl explained that he was repairing a service lateral and curb stop that initially a plumber was hired to do. While the plumber was making the repairs he broke one of the shut off valves, (Curb Stop.) Before leaving the work site I asked Earl to make sure that his traffic control was corrected with proper signage.

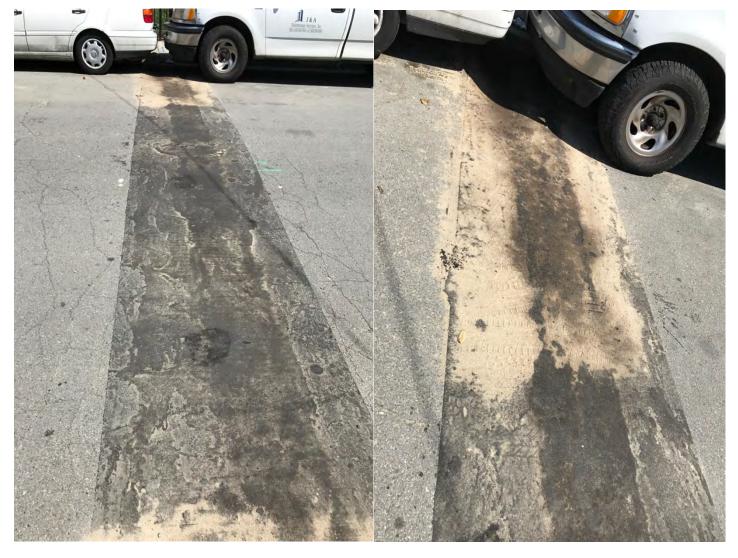
Location: 2292 Poplar Avenue (April 10, 2017) Picture 2&3 of 3

Violations:	The above picture depicts an illegal excavation.
	Work without a City permit
	No inspections from City staff
	Patch work does not meet City standards

I also noticed within the excavation of the water main no shoring protection while Earl was straddling the water main. Although traffic vibrations were at a minimum, loose granulated soils and mixed soils types such as A, B, and C would dictate a risk of cave-in. The excavation was less than 4 feet deep, but more than 40 inches in depth. There were many other safety violations such as; no cones and/or protective warning signage and no warning tape around heavy equipment staged on the City right of way (ROW).

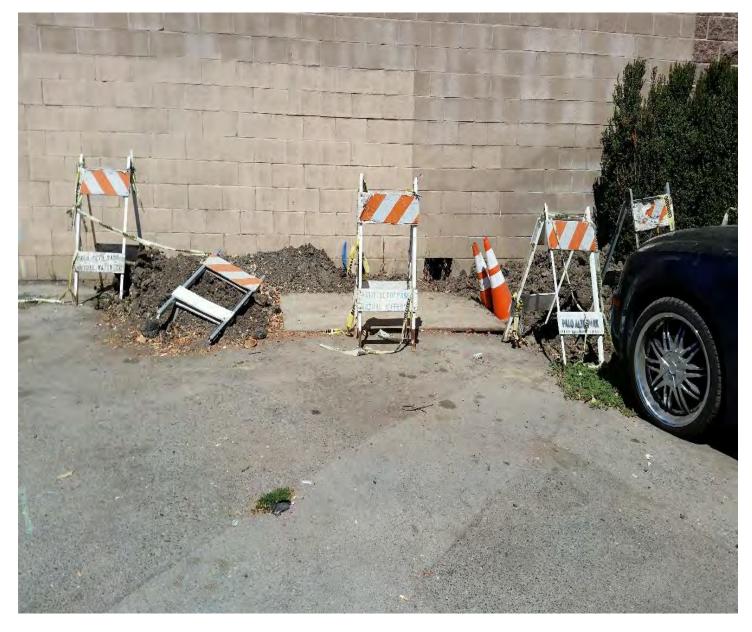
Location: Sound-wall at the end of Poplar Avenue, cross street Green Street (August 10, 2016)
Witness: Kevin Lewis (Engineering Division)

witness: Revin Lewis (Engineering Division)	
Violations:	The above picture depicts the illegal excavation at the base of the soundwall next to
	southbound Highway 101.
	Work without a City permit
	No inspections were conducted by City staff
	No USA (811) markings
	Improperly secured excavation site
	(see following witness narrative)

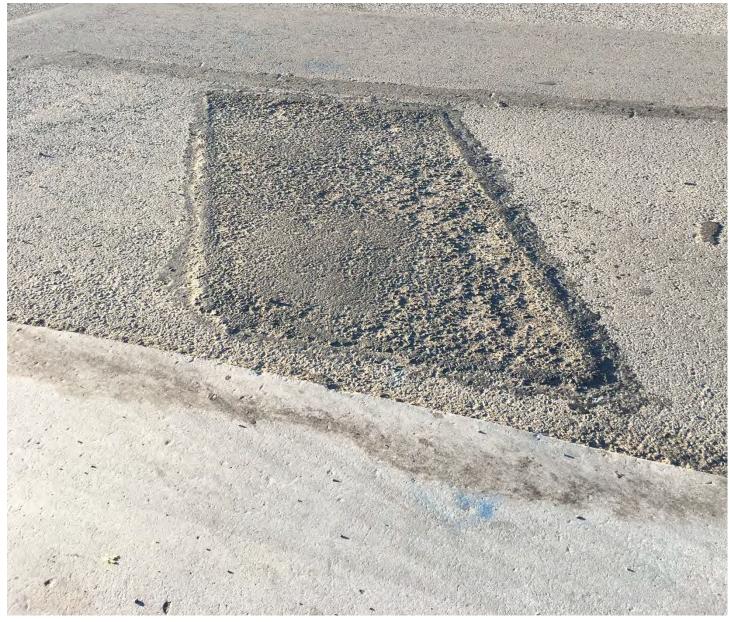
Location: Intersection of Poplar Avenue & East Bayshore Road (photographed 12/2/16)

The above picture depicts an excavation.

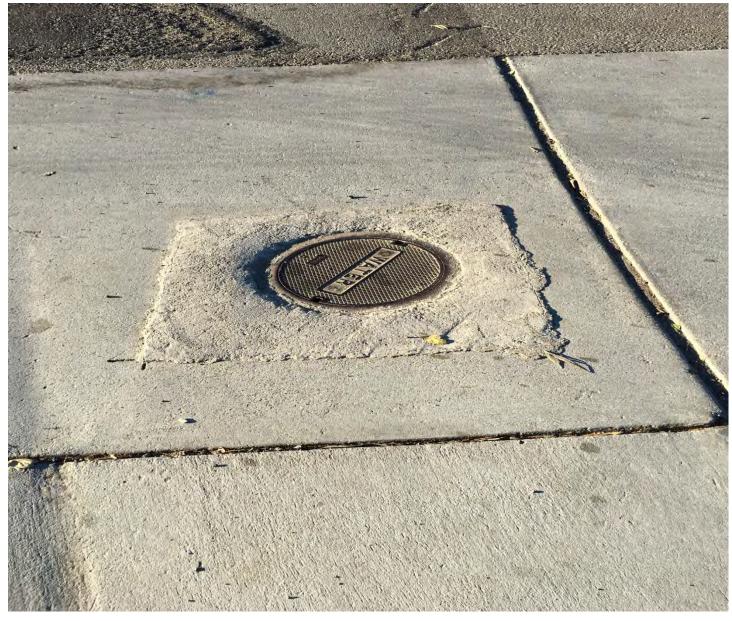
Location: Intersection of Poplar Avenue & East Bayshore Road (photographed 12/2/16)

The above picture depicts an excavation.

1
This work is constistent with a valve stem repair
• There are no markings from USA (811) around the excavation site
No encroachment permits were found in City records
 No inspections were conducted by City staff
The replacement asphalt is not in accordance with City standards
• The edges of the excavation is not "flush" with the gutter

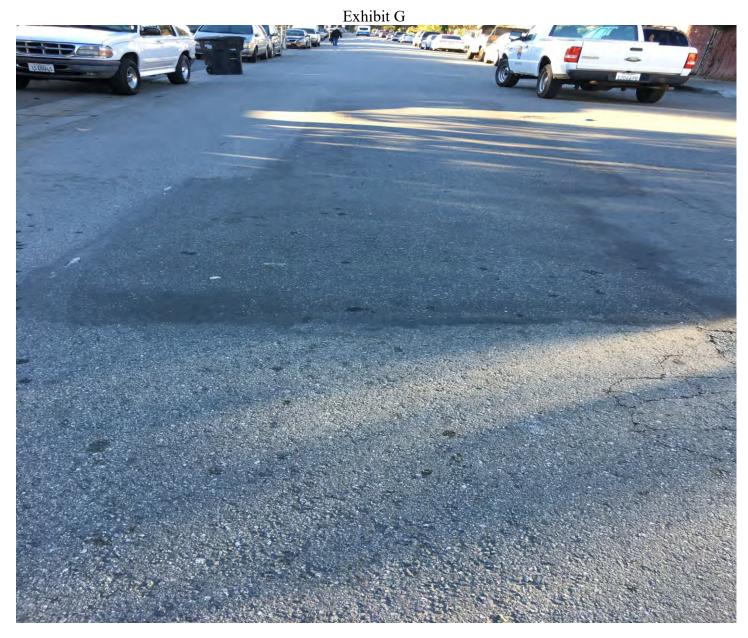
Location: 2292 Addison Avenue (photographed 12/2/16) The above picture depicts an excavation.

This is consistent with a main repair

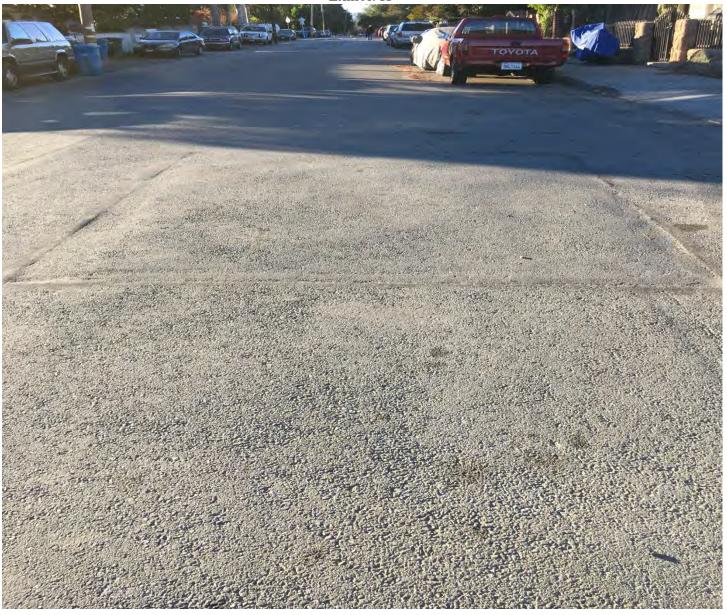
Location: 2252 Addison Avenue (photographed 12/2/16)

4 6 1
Violations:	The above picture depicts an excavation.
	This is consistent with a main repair
	 There are no markings from USA (811) around the excavation site
	 No encroachment permits were found in City records
	 No inspections were conducted by City staff
	The replacement asphalt is not in accordance with City standards

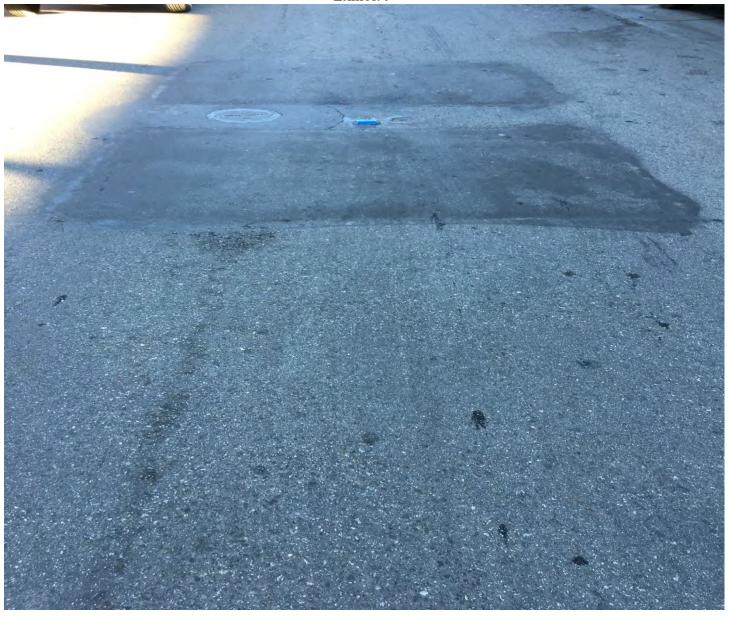
Location: 2242 Addison Avenue (photographed 12/2/16)

Violations:	The above picture depicts an excavation.
	This is consistent with a main repair
	• There are no markings from USA (811) around the excavation site
	No encroachment permits were found in City records
	No inspections were conducted by City staff
	The replacement asphalt is not in accordance with City standards

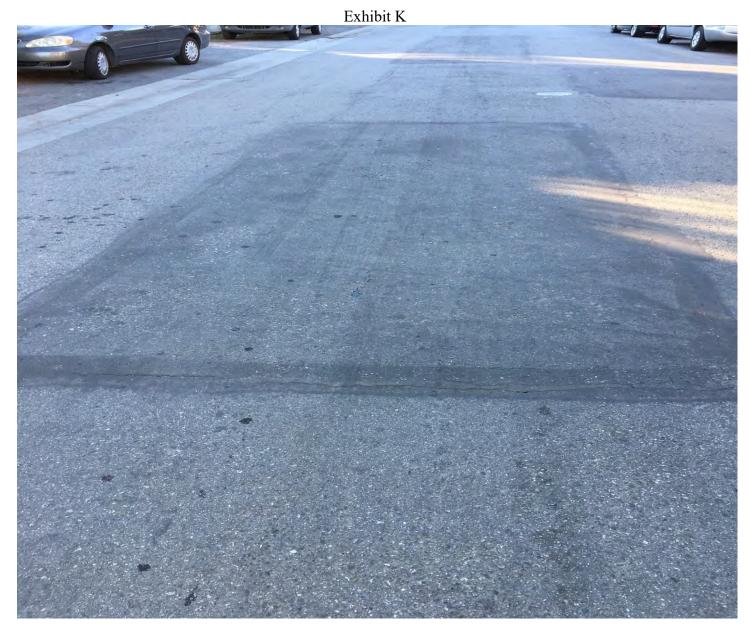
Location: 2242 Addison Avenue (photographed 12/2/16)

Location: 2242 Addison Avenue (photographed 12/2/10)			
Violations:	The above picture depicts an excavation.		
	This is consistent with a main repair		
	 There are no markings from USA (811) around the excavation site 		
	No encroachment permits were found in City records		
	No inspections were conducted by City staff		
	The replacement asphalt is not in accordance with City standards

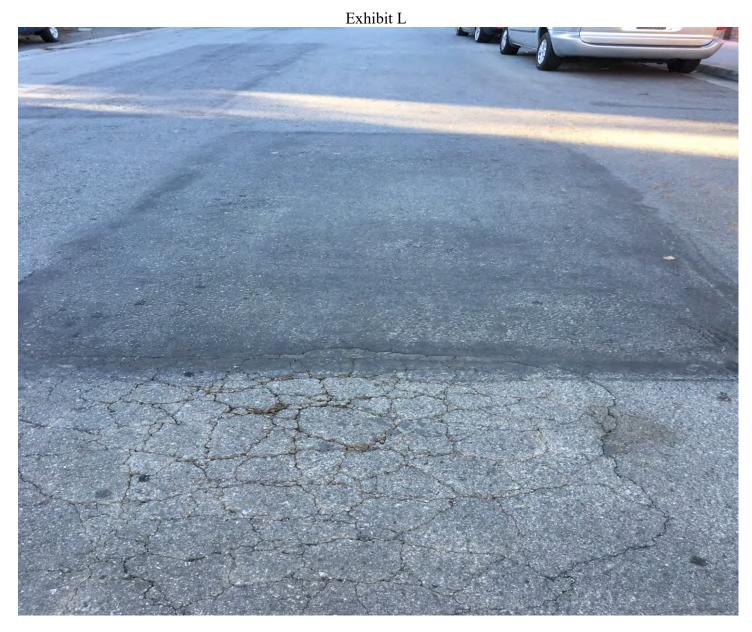
Location: 2231 Addison Avenue (photographed 12/2/16)

Violations:	The above picture depicts an excavation.
	This is consistent with a main repair
	• There are no markings from USA (811) around the excavation site
	No encroachment permits were found in City records
	No inspections were conducted by City staff
	The replacement asphalt is not in accordance with City standards
	 The cracking asphalt around the excavation is consistent with poor compaction of the backfill material
	 Cracking beside the work area shows the soil is failing adjacent to the area of repair due to improper work

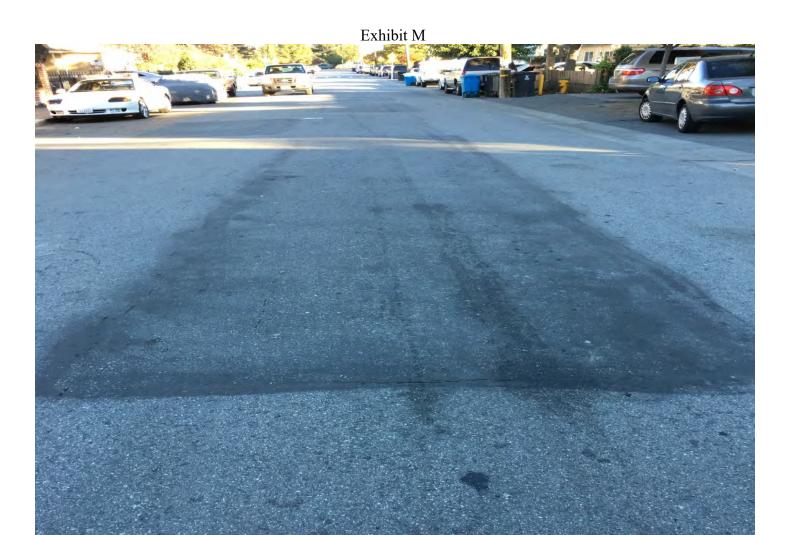
Location: 2238 Addison Avenue (photographed 12/2/16)

zeomien. zzeo i i anizen i i venar (priese graphe a i z z i v)			
Violations:	The above picture depicts an excavation.		
	This is consistent with a main repair		
 There are no markings from USA (811) around the excavation site 			
	No encroachment permits were found in City records		
	No inspections were conducted by City staff		
	The replacement asphalt is not in accordance with City standards

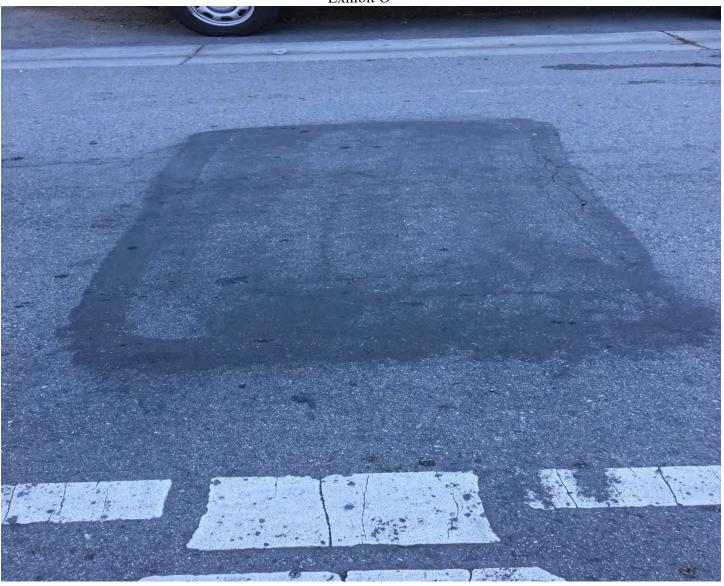
Location: 2223 Addison Avenue (photographed 12/2/16)

Violations:	The above picture depicts an excavation.
	This is consistent with a main repair
	• There are no markings from USA (811) around the excavation site
	No encroachment permits were found in City records
	No inspections were conducted by City staff
	The replacement asphalt is not in accordance with City standards
	 The cracking asphalt around the excavation is consistent with poor compaction of the backfill material
	 Cracking beside the work area shows the soil is failing adjacent to the area of repair due to improper work

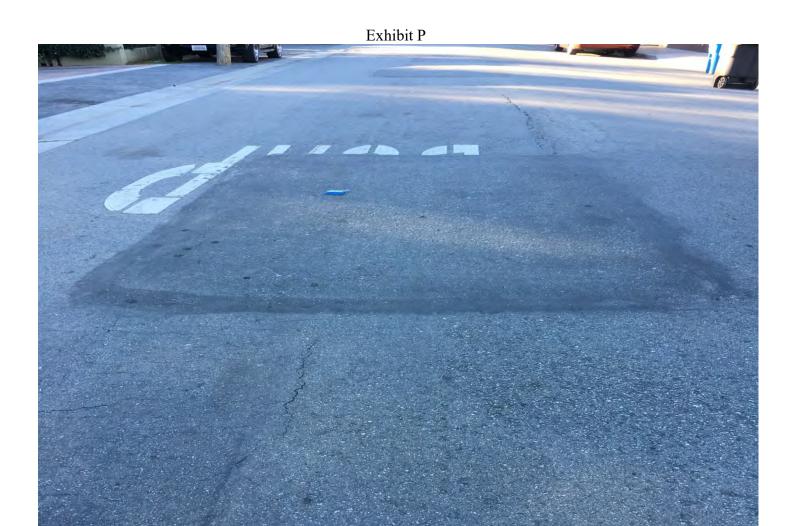
Location: 2226 Addison Avenue (photographed 12/2/16)
Violations:	The above picture depicts an excavation.
	This is consistent with a main repair
	• There are no markings from USA (811) around the excavation site
	 No encroachment permits were found in City records
	 No inspections were conducted by City staff
	The replacement asphalt is not in accordance with City standards
	• The "BUMP" sign on the street was not repainted once work was completed
	The cracking asphalt around the excavation is consistent with poor compaction of the backfill material
	 Cracking beside the work area shows the soil is failing adjacent to the area of repair due to improper work

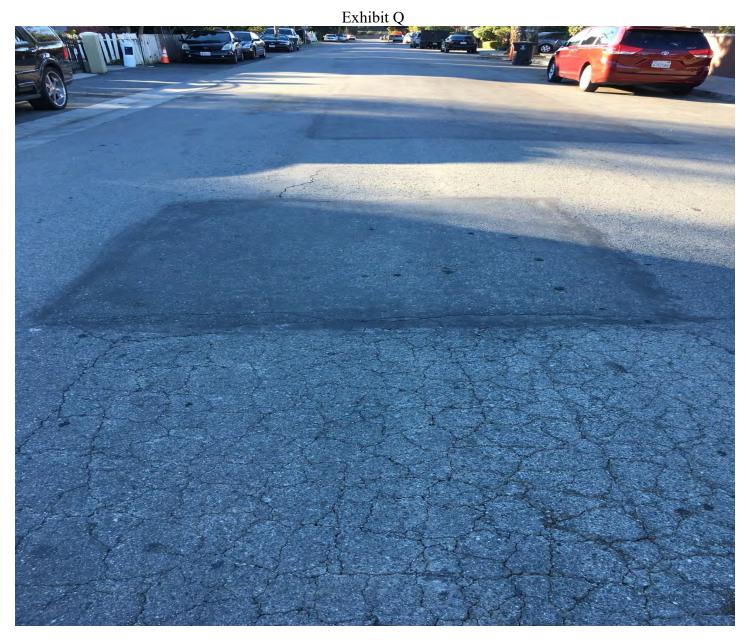
Location: 2222 Addison Avenue (photographed 12/2/16) The above picture depicts an excavation.

This is consistent with a main repair

No encroachment permits were found in City records No inspections were conducted by City staff
• The replacement asphalt is not in accordance with City standards
• The cracking asphalt around the excavation is consistent with poor compaction of the backfill material
• Cracking beside the work area shows the soil is failing adjacent to the area of repair due to improper work

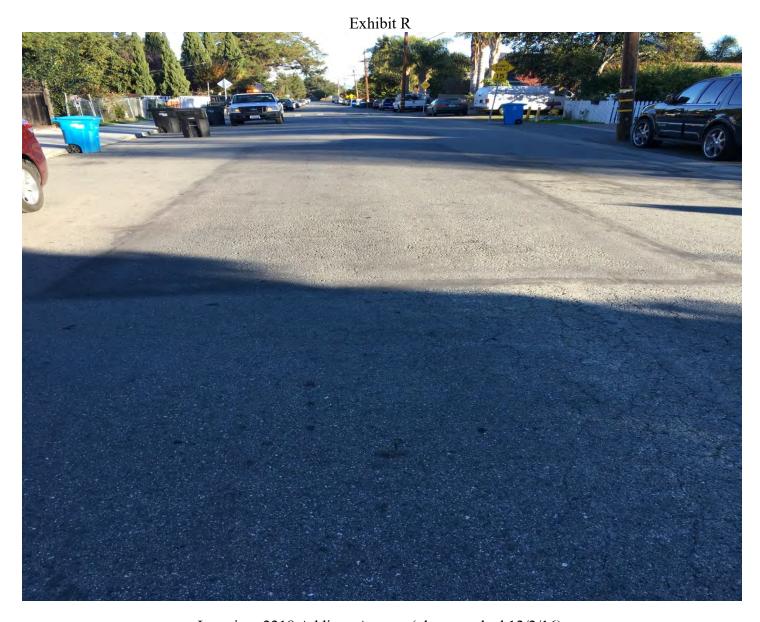
Location: 2218 Addison Avenue (photographed 12/2/16)

• This is consistent with a main repair

- 1	1
	• There are no markings from USA (811) around the excavation site
	No encroachment permits were found in City records
	 No inspections were conducted by City staff
	The replacement asphalt is not in accordance with City standards
	The cracking asphalt around the excavation is consistent with poor compaction of the backfill material
	• Cracking beside the work area shows the soil is failing adjacent to the area of repair due to improper work

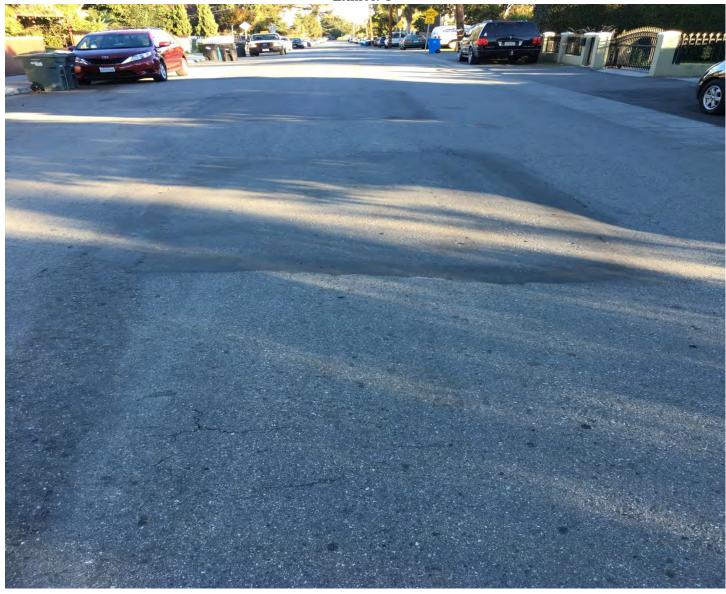
Location: 2207 Addison Avenue (photographed 12/2/16)

zeowien zeo i i anie i i i i i i i i i i i i i i i i i i			
Violations:	The above picture depicts an excavation.		
	This is consistent with a main repair		
	 There are no markings from USA (811) around the excavation site 		
	No encroachment permits were found in City records		
	No inspections were conducted by City staff		
	The replacement asphalt is not in accordance with City standards

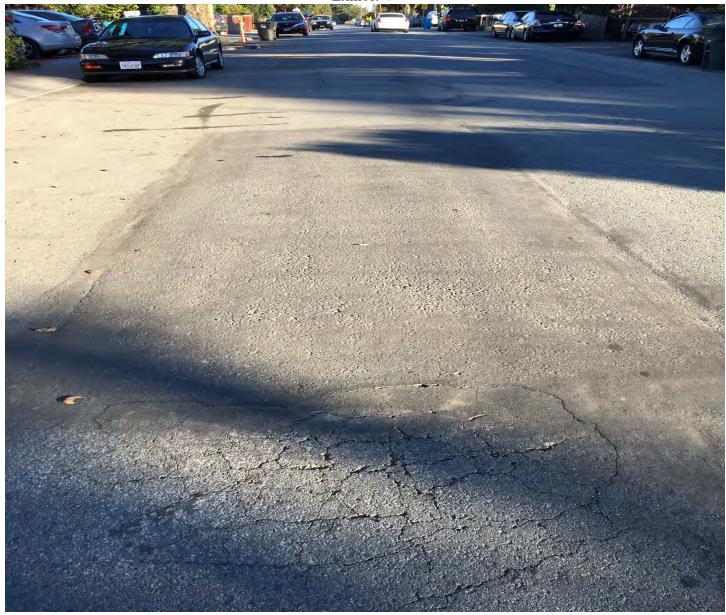
Location: 2203 Addison Avenue (photographed 12/2/16)

- This is consistent with a main repair
- There are no markings from USA (811) around the excavation site
- No encroachment permits were found in City records
- No inspections were conducted by City staff
- The replacement asphalt is not in accordance with City standards
- The cracking asphalt around the excavation is consistent with poor compaction of the backfill material
- Cracking beside the work area shows the soil is failing adjacent to the area of repair due to improper work

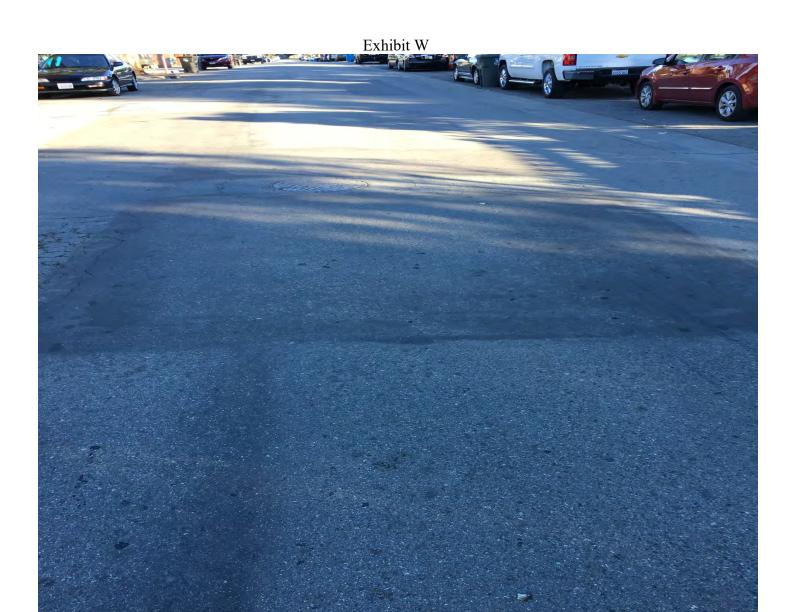
Location: 2203 Addison Avenue (photographed 12/2/16)
Violations:	The above picture depicts an excavation.
	This is consistent with a main repair
	 There are no markings from USA (811) around the excavation site
	 No encroachment permits were found in City records
	 No inspections were conducted by City staff
	The replacement asphalt is not in accordance with City standards
	 The cracking asphalt around the excavation is consistent with poor compaction of the backfill material
	 Cracking beside the work area shows the soil is failing adjacent to the area of repair due to improper work

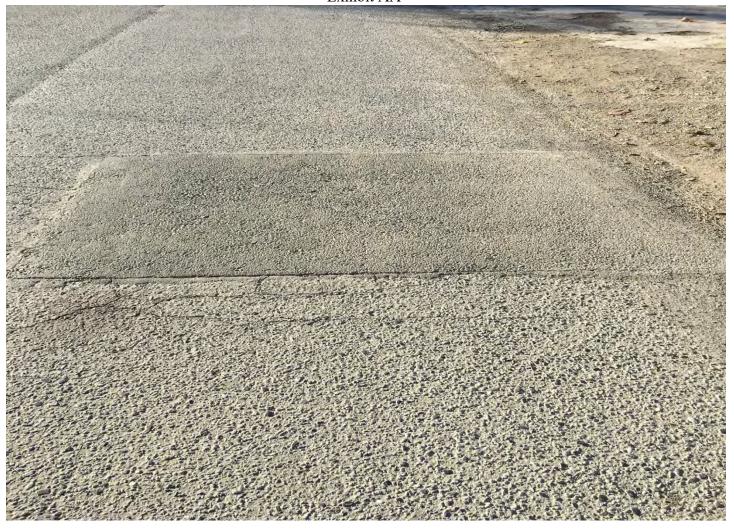
Location: 2161 Addison Avenue (photographed 12/2/16)
The above picture depicts an excavation.

zeomen zioi ilamanii (hiero grapho iz zio)
Violations:	The above picture depicts an excavation.
	This is consistent with a service lateral repair
	 There are no markings from USA (811) around the excavation site
	No encroachment permits were found in City records
	No inspections were conducted by City staff
	The replacement asphalt is not in accordance with City standards
	 The cracking asphalt around the excavation is consistent with poor compaction of the backfill material
	• Cracking beside the work area shows the soil is failing adjacent to the area of repair due to improper work

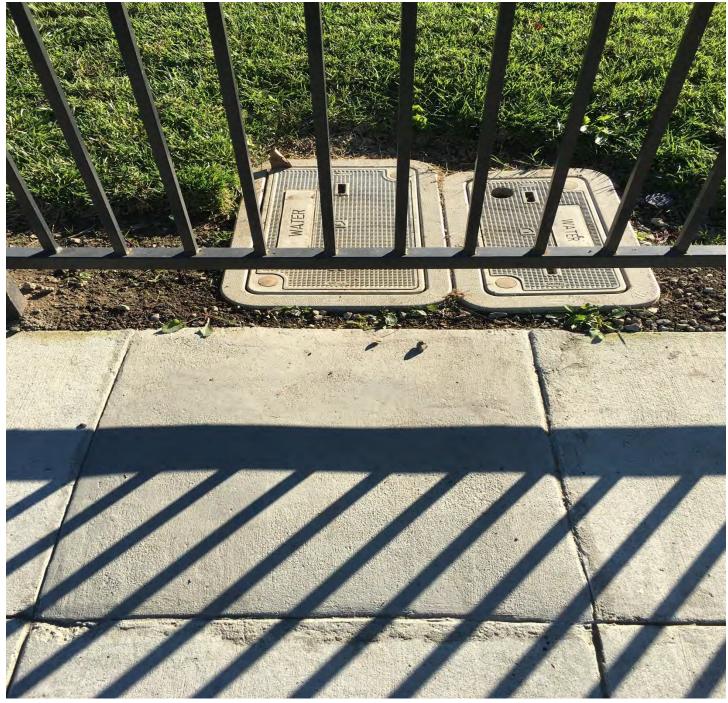
Location: 2216 Dumbarton Avenue (photographed 12/2/16)

Violations:	The above picture depicts the excavation on the sidewalk.
	Work was done without a City permit
	 No inspections by City staff were conducted

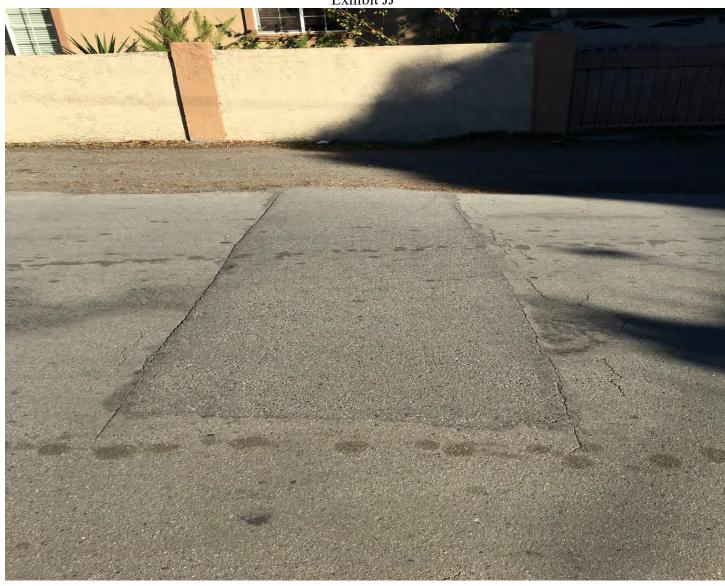
Location: 401 Runnymede Street (photographed 12/2/16)

This is consistent with a lateral repair

• There are no markings from USA (811) around the excavation site
No encroachment permits were found in City records
 No inspections were conducted by City staff
• The replacement asphalt is not in accordance with City standards
The cracking asphalt around the excavation is consistent with poor
compaction of the backfill material
• Cracking beside the work area shows the soil is failing adjacent to the area of
renair due to improper work

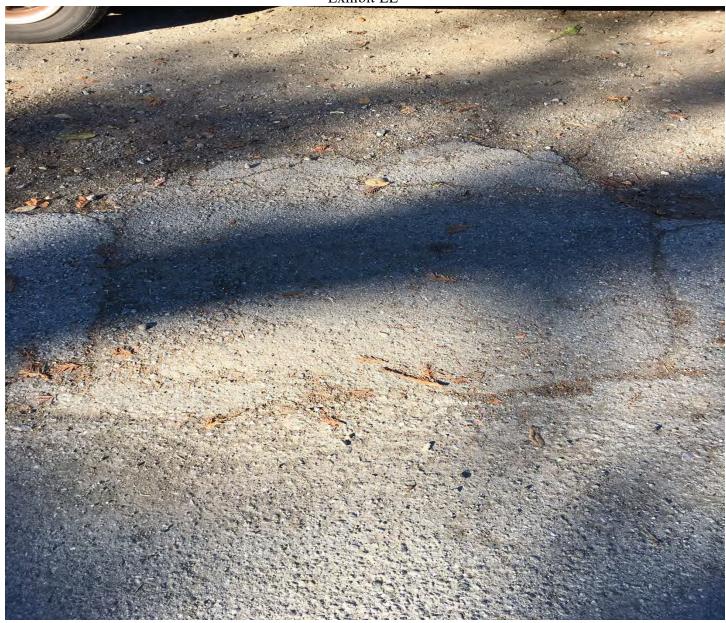
Location: 2366 Glen Way (photographed 12/2/16)

- This is consistent with a lateral repair
- There are no markings from USA (811) around the excavation site
- No encroachment permits were found in City records
- No inspections were conducted by City staff
- The replacement asphalt is not in accordance with City standards
- The cracking asphalt around the excavation is consistent with poor compaction of the backfill material
- Cracking beside the work area shows the soil is failing adjacent to the area of repair due to improper work

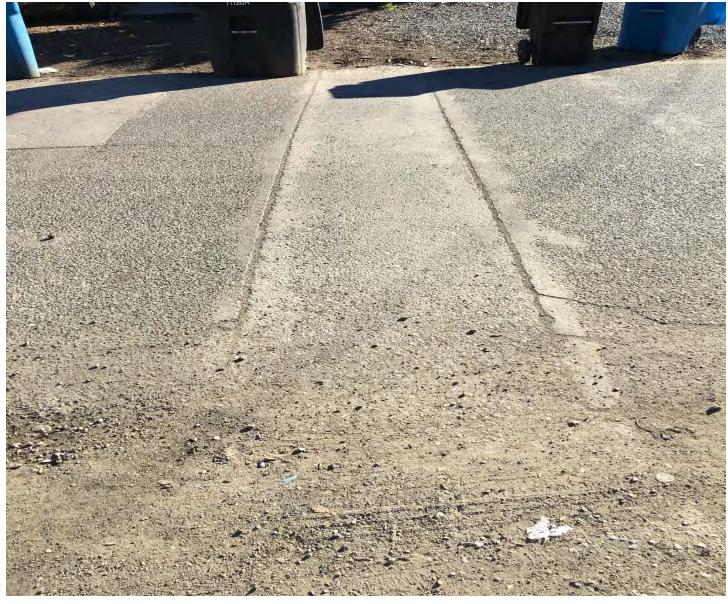
Location: 2280 Glen Way (photographed 12/2/16)
The above picture depicts an excavation along the width of Glen Way.

repair due to improper work

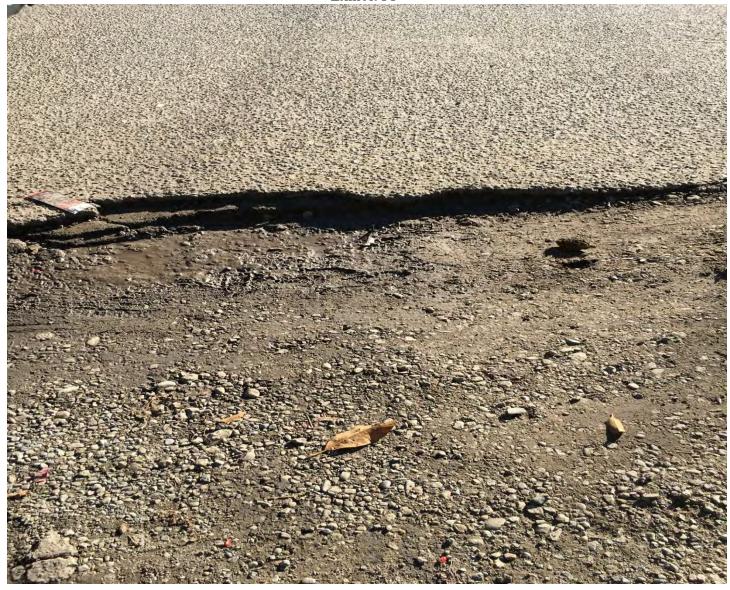
Location: 2249 Glen Way (photographed 12/2/16)

zeomien zz is eien way (priete gruphen iz zwie)
Violations:	The above picture depicts an excavation.
	This is consistent with a service repair
	• There are no markings from USA (811) around the excavation site
	No encroachment permits were found in City records
	 No inspections were conducted by City staff
	The replacement asphalt is not in accordance with City standards and not
	"flush"
