City of East Palo Alto

Investigation into Palo Alto Park Mutual Water Company

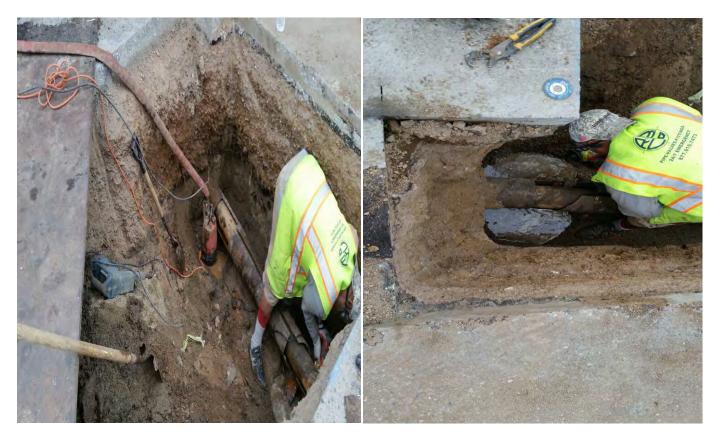
Location: Intersection of Poplar Avenue & East Bayshore Road (October 25, 2016)
Witnesses: Kevin Lewis (Engineering Division), Donald Timoteo (Building Division) & Kamal Fallaha
(Engineering Division)
Picture 1 & 2 of 3

Violations:	The above pictures depict an illegal excavation.
	This is consistent with a water main repair
	• There are no markings from USA (811) around the excavation site
	No encroachment permits were found in City records
	 No inspections were conducted by City staff
	The replacement asphalt is not in accordance with City standards
	Incorrect shoring
	No qualified flagger
	No proper traffic control for project
	• Insufficient Personal Protection Equipment (PPE)
	(see following witness narratives)

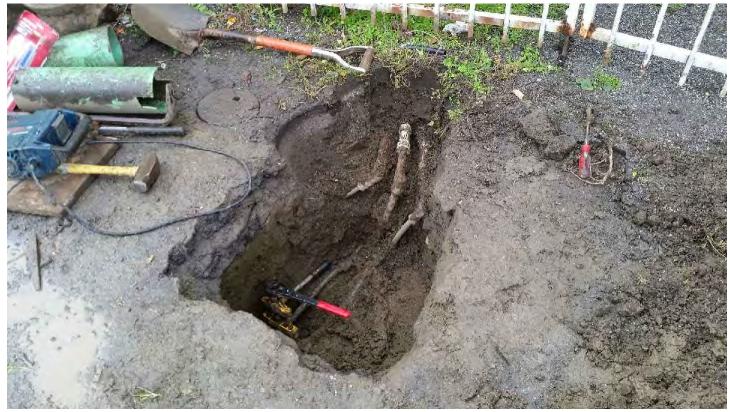
Location: Between 1435 & 1437 East Bayshore Road (December 30, 2016)
Witness: Kevin Lewis (Engineering Division)
Picture 2 of 4

Violations:	The above picture depicts an illegal excavation.
	This is consistent with a valve repair
	No encroachment permits were found in City records
	No inspections were conducted by City staff
	The replacement asphalt is not in accordance with City standards

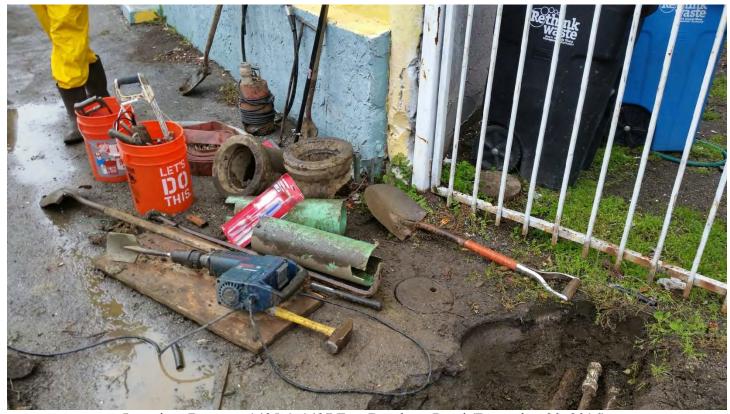
Location: Between 1435 & 1437 East Bayshore Road (December 30, 2016)
Witness: Kevin Lewis (Engineering Division)
Picture 3 of 4

Violations:	The above picture depicts an illegal excavation.
	This is consistent with a valve repair
	No encroachment permits were found in City records
	 No inspections were conducted by City staff
	The replacement asphalt is not in accordance with City standards

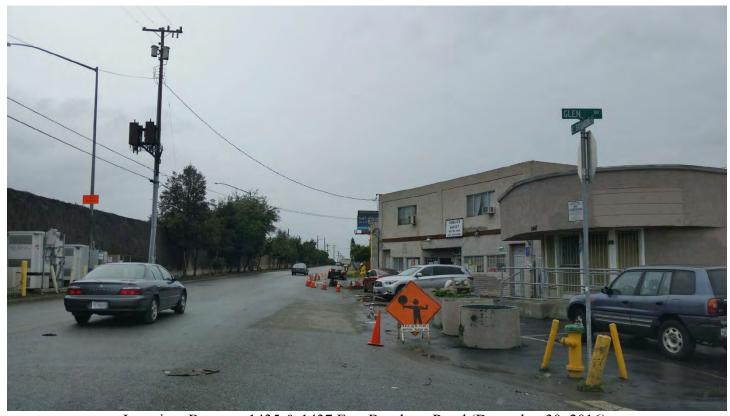
Location: Between 1435 & 1437 East Bayshore Road (December 30, 2016)
Witness: Kevin Lewis (Engineering Division)
Picture 4 of 4

Violations:	The above picture depicts an improper traffic control for an illegal excavation.
	 No traffic control plan was submitted for City review
	 No notification was given to the City for this project
	 Traffic control layout is incorrect

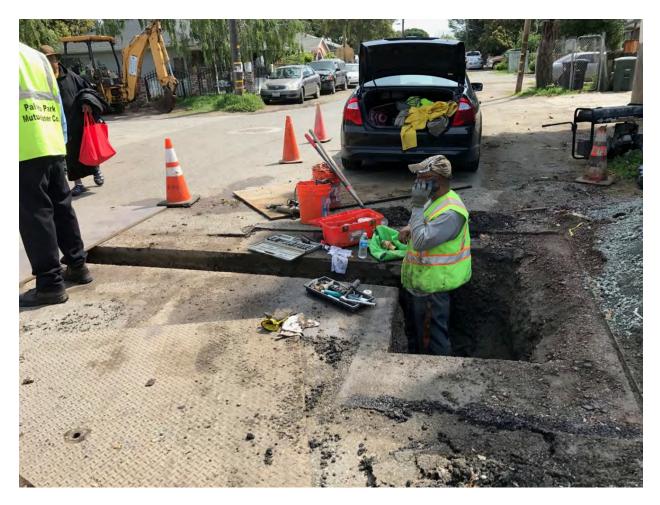
Location: 2292 Poplar Avenue (April 10, 2017) Picture 1 of 3

Violations:	The above picture depicts an illegal excavation.
	Incorrect shoring
	Incorrect traffic control
	Work without a City permits
	No inspections from City staff

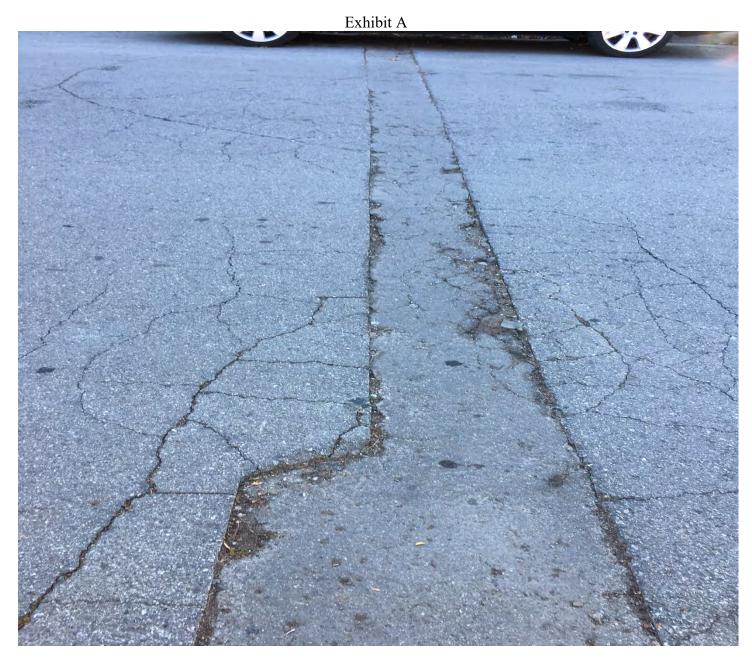
Location: 2292 Poplar Avenue (photographed 12/2/16)

Violations:	The above picture depicts the excavation across the width of Poplar Avenue.
	This is consistent with a service line replacement
	 The cracking asphalt on both sides of the excavation are consistent with poor compaction of the backfill material
	 Cracking besides the work area shows the soil is failing adjacent to the area of repair due to improper work
	There are no markings from USA (811) around the excavation site
	No encroachment permits were found in City records
	No inspections were conducted by City staff
	The replacement asphalt is not in accordance with City standards

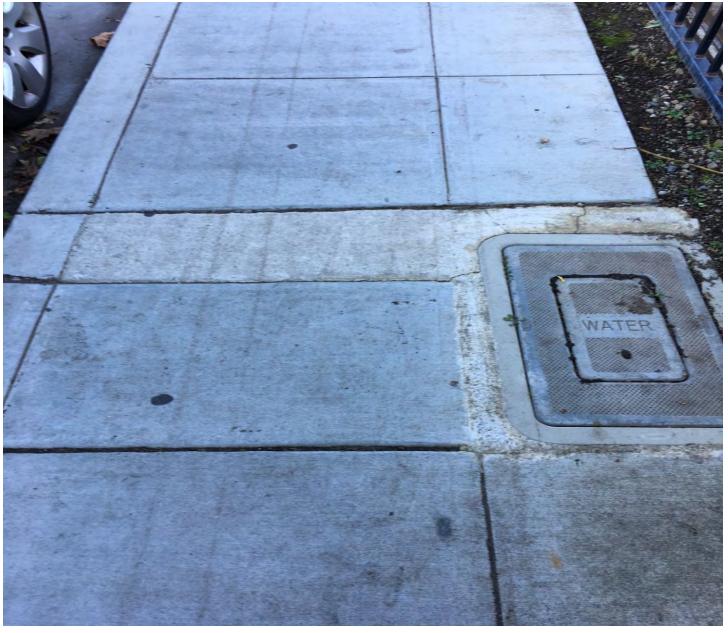
Location: 2292 Poplar Avenue (photographed 12/2/16)

Violations:	The above picture depicts the continuation of a service line replacement from the street into the sidewalk and to the utility box.
	• The utility box location is inconsistent with ADA standards for location and installation
	• The concrete type used to fill in the sidewalk cut is not the same material used for the rest of the sidewalk and is beginning to crack around the box
	 This work does not have the required permit according to City records and no inspections were conducted
	This sidewalk has no markings from USA (811)

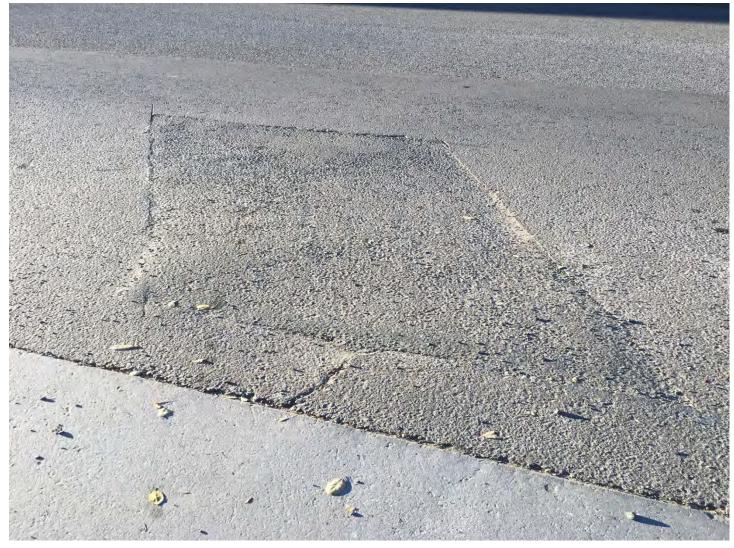
Location: Intersection of Poplar Avenue & East Bayshore Road (photographed 12/2/16)

Violations:	The above picture depicts an excavation.
	This is consistent with a water main excavation
	• There are no markings from USA (811) around the excavation site
	 No encroachment permits were found in City records for this work
	 No inspections were conducted by City staff
	The replacement asphalt is not in accordance with City standards

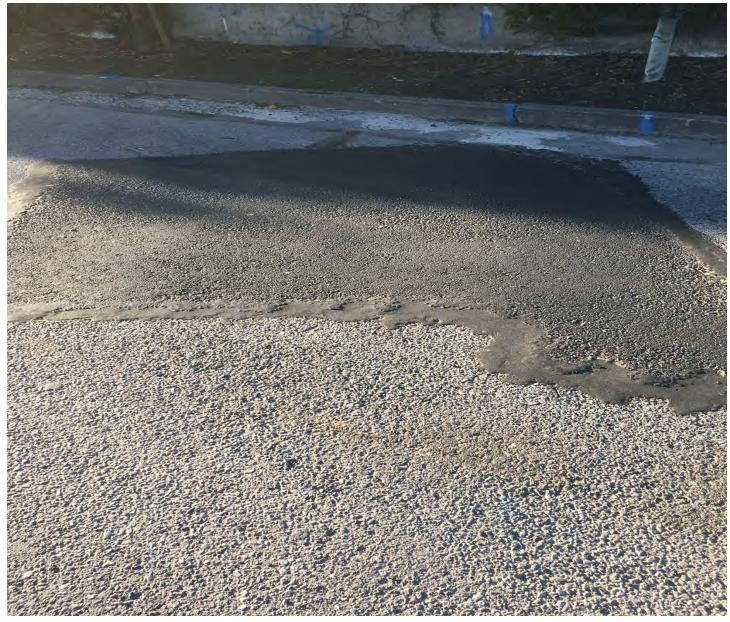
Location: Intersection of Poplar Avenue & East Bayshore Road (photographed 12/2/16)

Violations:	The above picture depicts an excavation.
	 This is consistent with a water main excavation
	 No encroachment permits were found in City records for this work
	 No inspections were conducted by City staff
	The replacement asphalt is not in accordance with City standards
	 Asphalt around edge of excavation is not "flush" with the street

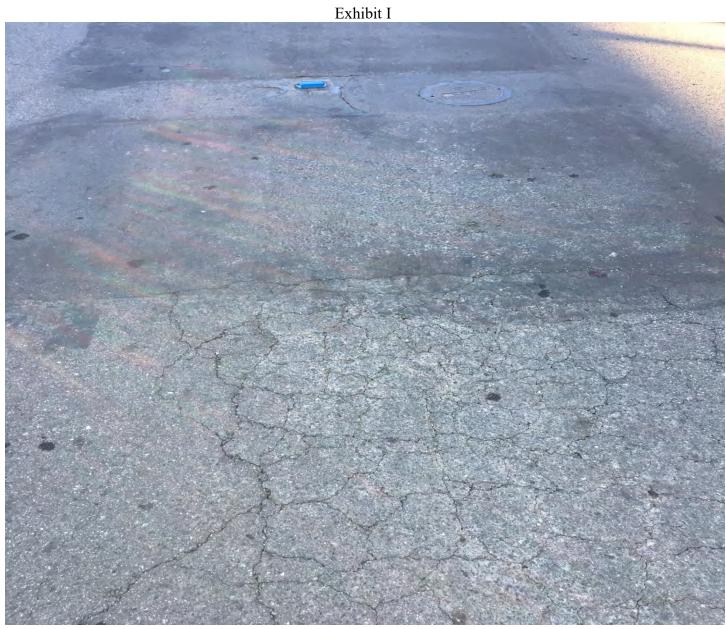
Location: 2248 Addison Avenue (photographed 12/2/16)
The above picture depicts an excavation.

Violations:	The above picture depicts an excavation.
	This is consistent with a main repair
	 There are no markings from USA (811) around the excavation site
	 No encroachment permits were found in City records
	 No inspections were conducted by City staff
	 The replacement asphalt is not in accordance with City standards
	 The cracking asphalt around the excavation is consistent with poor compaction of the backfill material
	 Cracking beside the work area shows the soil is failing adjacent to the area of repair due to improper work

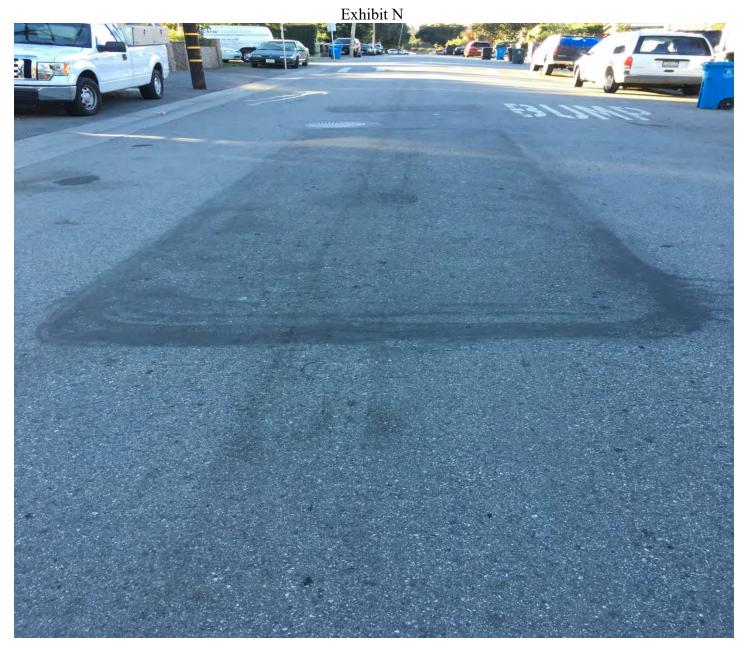
Location: 2223 Addison Avenue (photographed 12/2/16)

Escation: 2223 radison revenue (photographed 12/2/10)		
Violations:	The above picture depicts an excavation.	
	This is consistent with a main repair	
There are no markings from USA (811) around the excavation site		
	 No encroachment permits were found in City records 	
	 No inspections were conducted by City staff 	
	The replacement asphalt is not in accordance with City standards

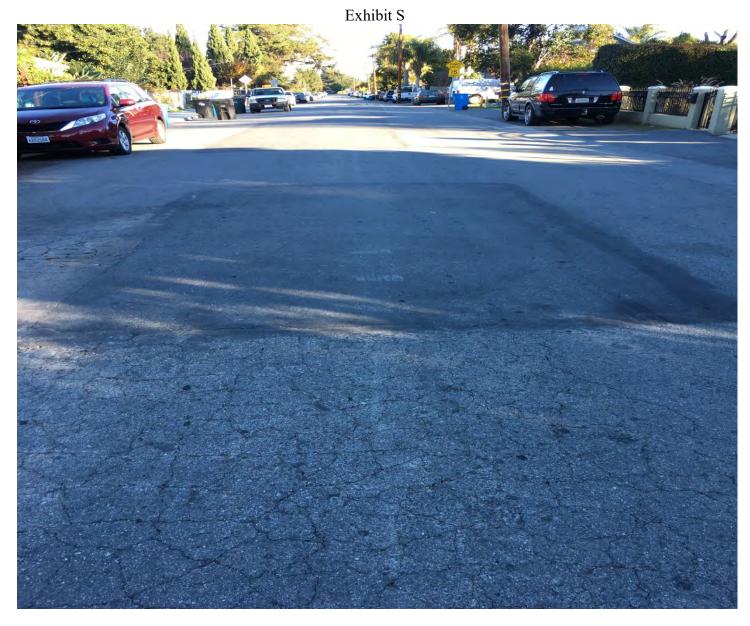
Location: 2212 Addison Avenue (photographed 12/2/16) The above picture depicts an excavation.

•	This is consistent with a main repair
•	There are no markings from USA (811) around the excavation site
•	No encroachment permits were found in City records
•	No inspections were conducted by City staff
•	The replacement asphalt is not in accordance with City standards
•	The cracking asphalt around the excavation is consistent with poor compaction of the backfill material
•	Cracking beside the work area shows the soil is failing adjacent to the area of repair due to improper work

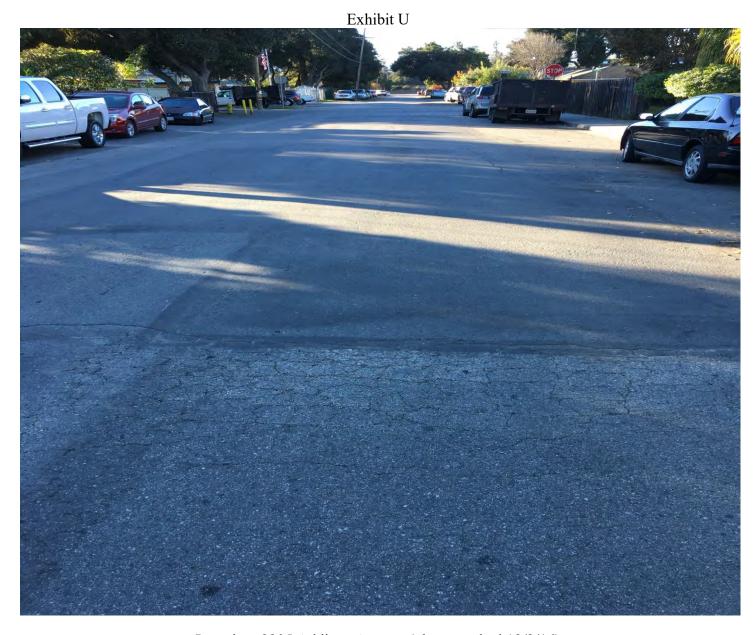
Location: 2205 Addison Avenue (photographed 12/2/16)

Violations:	The above picture depicts an excavation.
	This is consistent with a main repair
	• There are no markings from USA (811) around the excavation site
	No encroachment permits were found in City records
	No inspections were conducted by City staff
	The replacement asphalt is not in accordance with City standards
	 The cracking asphalt around the excavation is consistent with poor compaction of the backfill material
	 Cracking beside the work area shows the soil is failing adjacent to the area of repair due to improper work

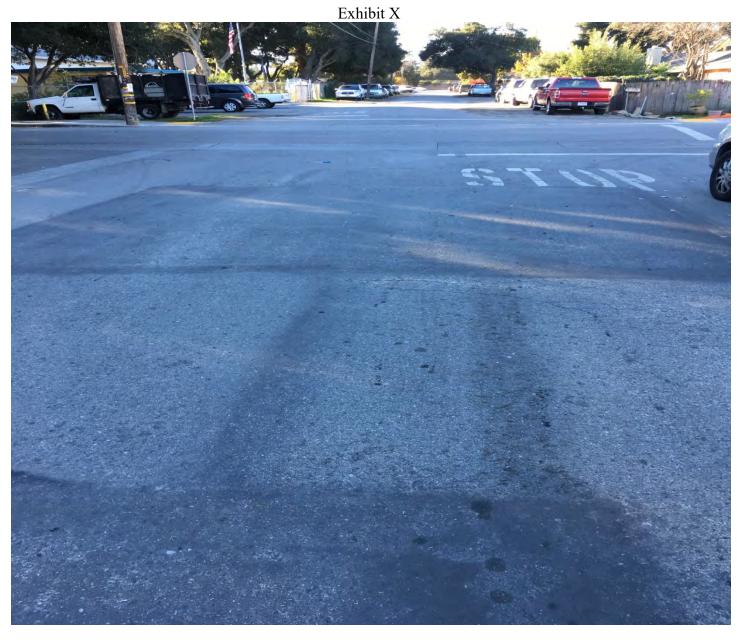
Location: 2203 Addison Avenue (photographed 12/2/16)

Violations:	The above picture depicts an excavation.
	 This is consistent with a main repair
	 There are no markings from USA (811) around the excavation site
	 No encroachment permits were found in City records
	 No inspections were conducted by City staff
	 The replacement asphalt is not in accordance with City standards
	 The cracking asphalt around the excavation is consistent with poor compaction of the backfill material
	 Cracking beside the work area shows the soil is failing adjacent to the area of repair due to improper work

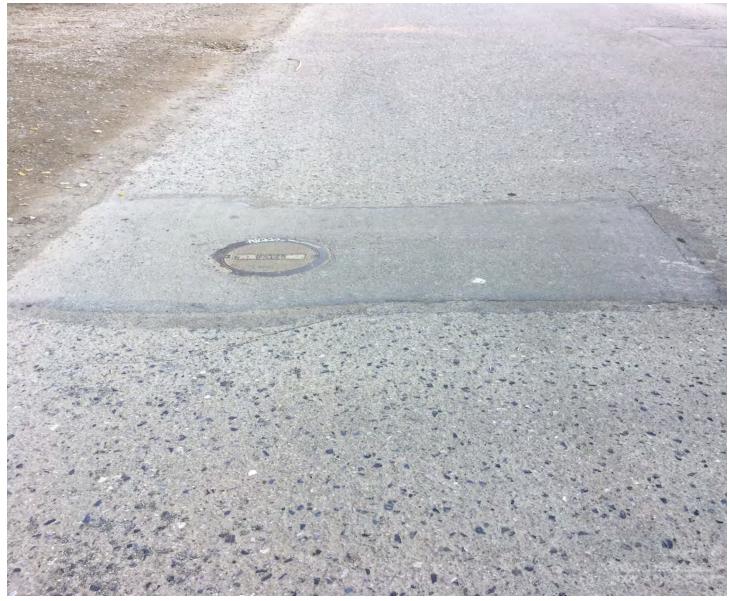
Location: 2169 Addison Avenue (photographed 12/2/16)

Location: 2107 Addison Avenue (photographed 12/2/10)
Violations:	The above picture depicts an excavation.
	This is consistent with a valve repair
	• There are no markings from USA (811) around the excavation site
	No encroachment permits were found in City records
	 No inspections were conducted by City staff
	The replacement asphalt is not in accordance with City standards

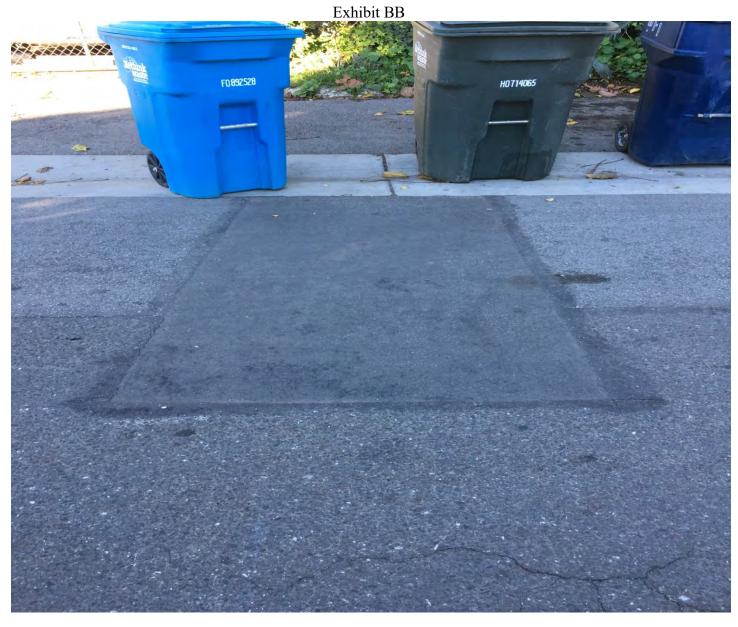
Location: 2216 Dumbarton Avenue (photographed 12/2/16)

Location. 2210 Dumoarton Avenue (photographed 12/2/10)
Violations:	The above picture depicts an excavation.
	This is consistent with a service lateral repair
	 There are no markings from USA (811) around the excavation site
	 No encroachment permits were found in City records
	 No inspections were conducted by City staff
	 The replacement asphalt is not in accordance with City standards

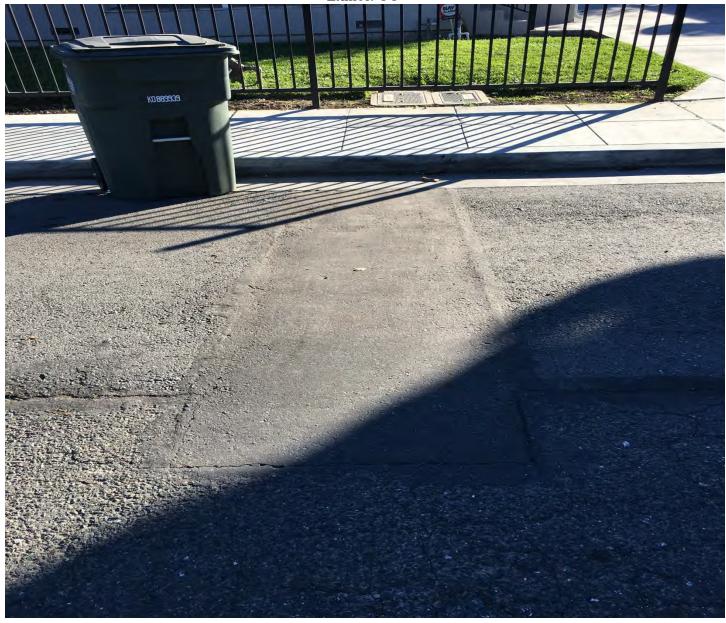
Location: 2216 Dumbarton Avenue (photographed 12/2/16)

Violations:	The above picture depicts an excavation.
	This is consistent with a service lateral repair
	• There are no markings from USA (811) around the excavation site
	 No encroachment permits were found in City records
	 No inspections were conducted by City staff
	• The replacement asphalt is not in accordance with City standards

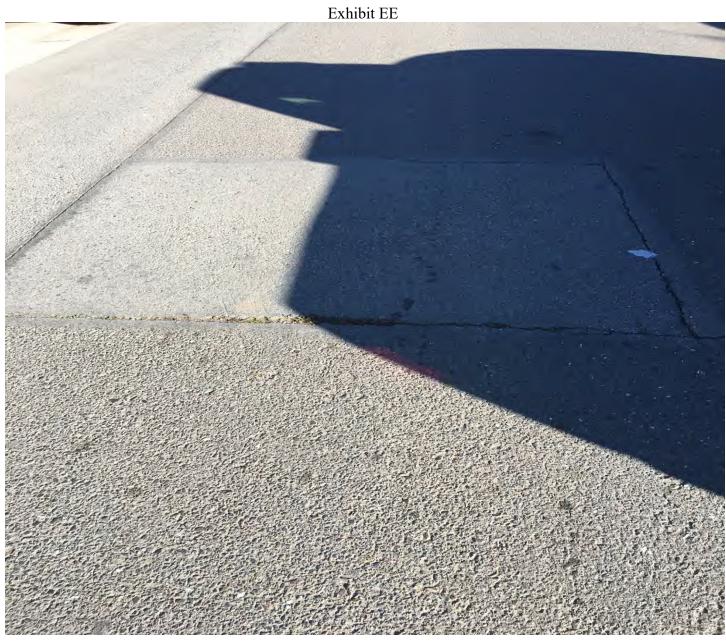
Location: 2291 Dumbarton Avenue (photographed 12/2/16)

Violations:	The above picture depicts an excavation.
	This is consistent with a service lateral repair
	 There are no markings from USA (811) around the excavation site
	 No encroachment permits were found in City records
	 No inspections were conducted by City staff
	The replacement asphalt is not in accordance with City standards

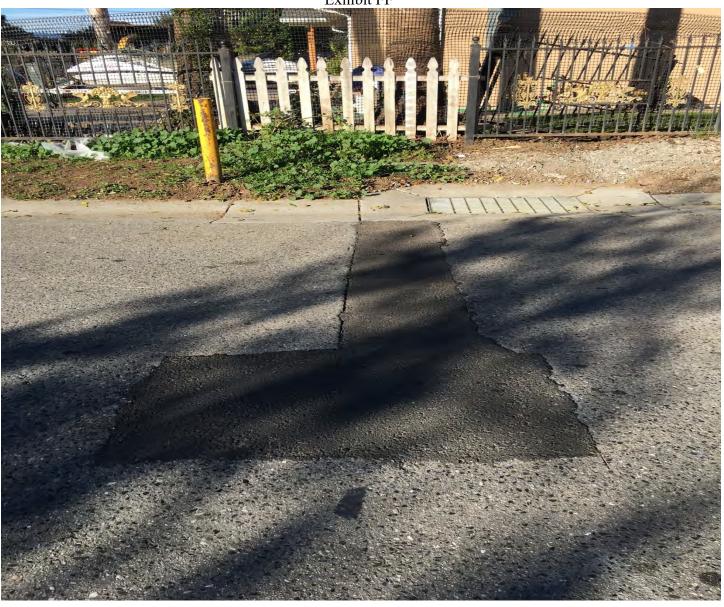
Location: 2382 Palo Verde Avenue (photographed 12/2/16)

Education: 2502 Faio Verde Tivende (photographed 12/2/10)
Violations:	The above picture depicts an excavation.
	This is consistent with a service lateral repair
	• There are no markings from USA (811) around the excavation site
	No encroachment permits were found in City records
	No inspections were conducted by City staff
	The replacement asphalt is not in accordance with City standards

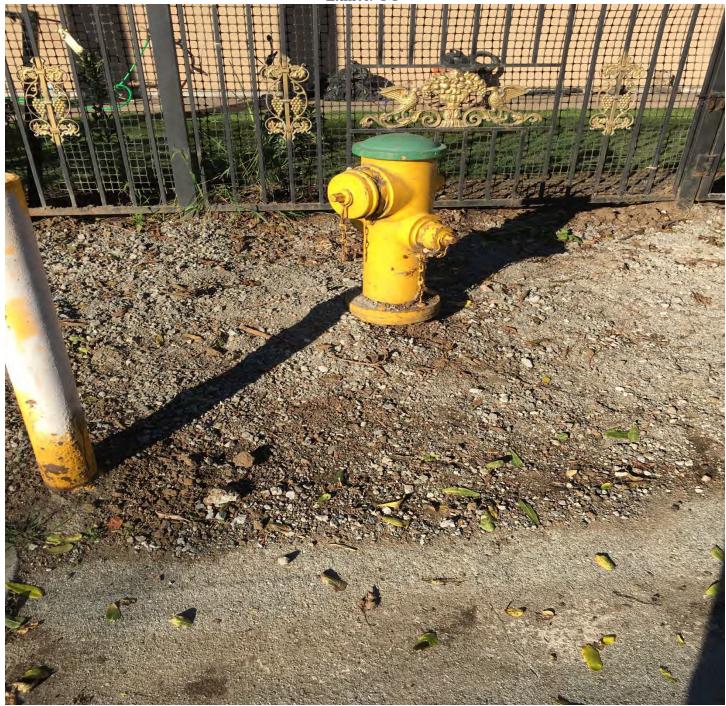
Location: 2382 Palo Verde Avenue (photographed 12/2/16)

Location: 2502 Faio Verde Tivende (photographed 12/2/10)
Violations:	The above picture depicts a hydrant repair.
	Illegal excavation
	 No City permit for the work
	 No inspections conducted by City staff
	No USA (811) markings
	 Fire hydrant is not the required minimum height

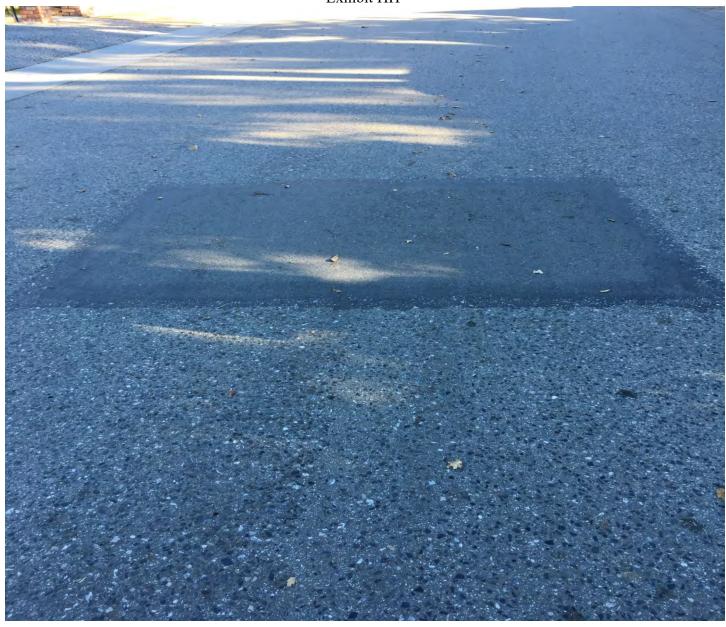
Location: 2351 Palo Verde Avenue (photographed 12/2/16)

Edeation: 2551 Tato Verde Avenue (photographed 12/2/10)
Violations:	The above picture depicts an excavation.
	 This is consistent with a main repair
	 There are no markings from USA (811) around the excavation site
	 No encroachment permits were found in City records
	 No inspections were conducted by City staff
	The replacement asphalt is not in accordance with City standards

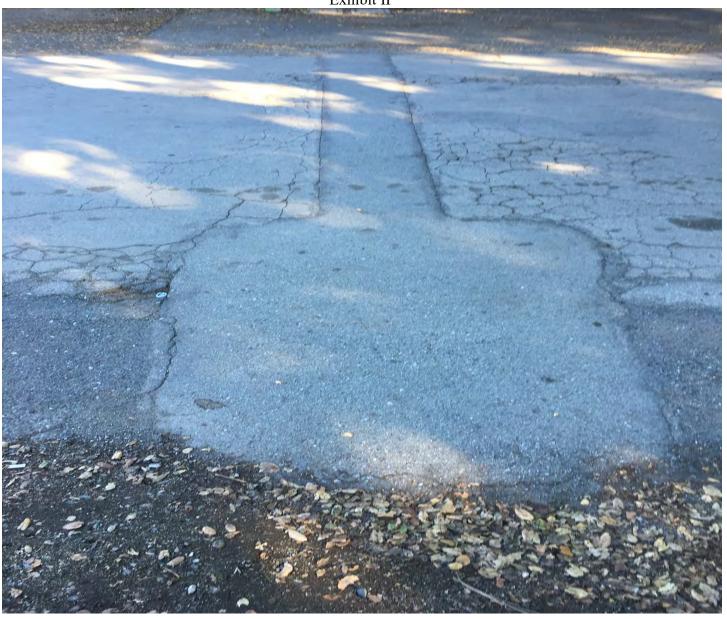
Location: 401 Runnymede Street (photographed 12/2/16)

Zoranom vor realing mode surver (photographica 12/2/10)
Violations:	The above picture depicts an excavation across the width of Runnymede Street.
	This is consistent with a lateral repair
	• There are no markings from USA (811) around the excavation site
	No encroachment permits were found in City records
	No inspections were conducted by City staff
	The replacement asphalt is not in accordance with City standards
	The cracking asphalt around the excavation is consistent with poor
	compaction of the backfill material
	• Cracking beside the work area shows the soil is failing adjacent to the area of
	repair due to improper work

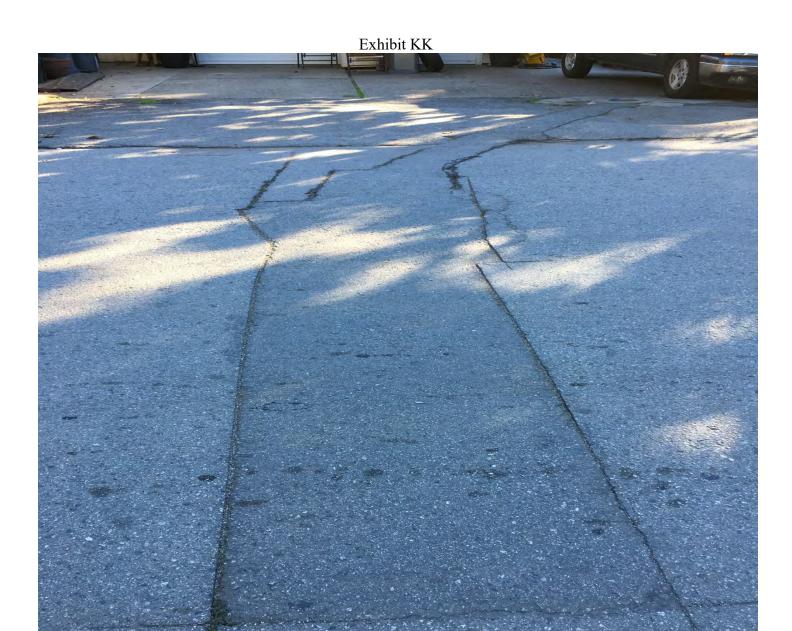
Location: 2366 Glen Way (photographed 12/2/16)

Violations:	The above picture depicts an excavation across the width of Glen Way.
, 10100101101	This is consistent with a lateral replacement
	• There are no markings from USA (811) around the excavation site
	 No encroachment permits were found in City records
	 No inspections were conducted by City staff
	The replacement asphalt is not in accordance with City standards

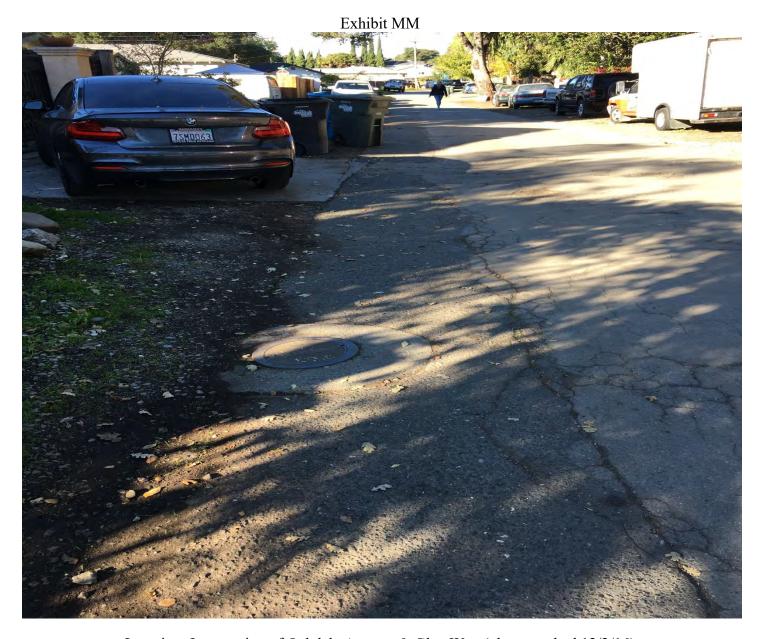
Location: Intersection of Oakdale Avenue & Glen Way (photographed 12/2/16)

The above picture depicts an excavation along the block length of Oakdale Avenue.

This is consistent with a main/valve replacement
 There are no markings from USA (811) around the excavation site
 No encroachment permits were found in City records
 No inspections were conducted by City staff
 The replacement asphalt is not in accordance with City standards
The cracking asphalt around the excavation is consistent with poor
compaction of the backfill material

Cracking beside the work area shows the soil is failing adjacent to the area of repair due to improper work

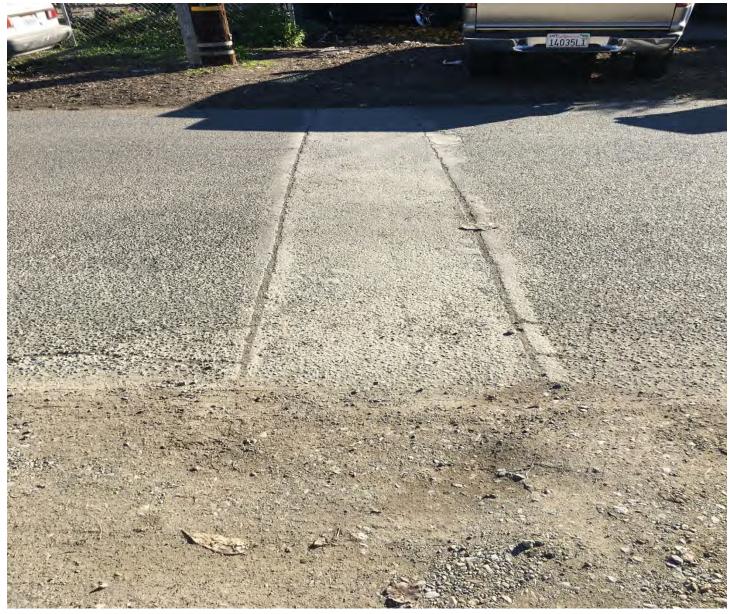
Location: 2270 Glen Way (photographed 12/2/16)

Violations:	The above picture depicts an excavation along the width of Glen Way.
	This is consistent with a lateral repair
	 There are no markings from USA (811) around the excavation site
	 No encroachment permits were found in City records
	 No inspections were conducted by City staff
	The replacement asphalt is not in accordance with City standards
	 The cracking asphalt around the excavation is consistent with poor compaction of the backfill material
	 Cracking beside the work area shows the soil is failing adjacent to the area of repair due to improper work

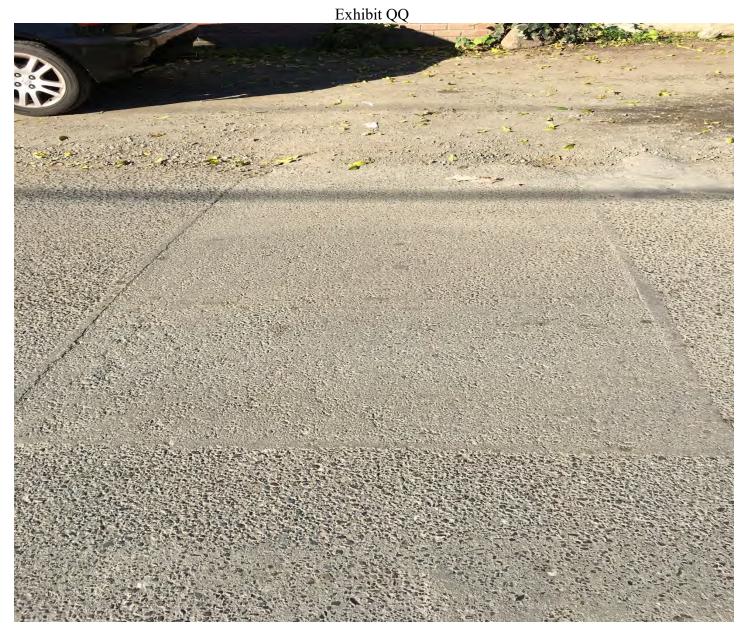
Location: 2179 Lincoln (photographed 12/2/16)

Violations:	The above picture depicts an excavation.
	This is consistent with a lateral repair
	 There are no markings from USA (811) around the excavation site
	 No encroachment permits were found in City records
	 No inspections were conducted by City staff
	The replacement asphalt is not in accordance with City standards

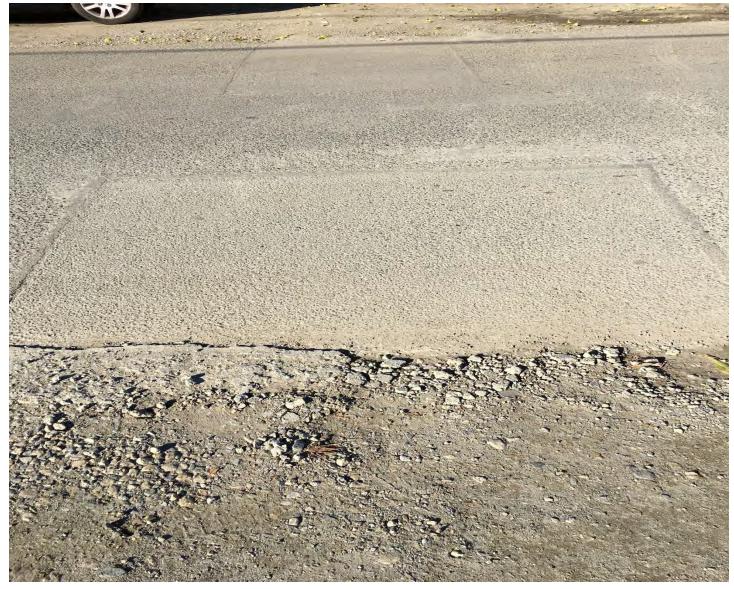
Location: 2179 Lincoln (photographed 12/2/16)

Violations:	The above picture depicts an excavation.
, 101 0 1101	This is consistent with a lateral repair
	• There are no markings from USA (811) around the excavation site
	No encroachment permits were found in City records
	No inspections were conducted by City staff
	The replacement asphalt is not in accordance with City standards

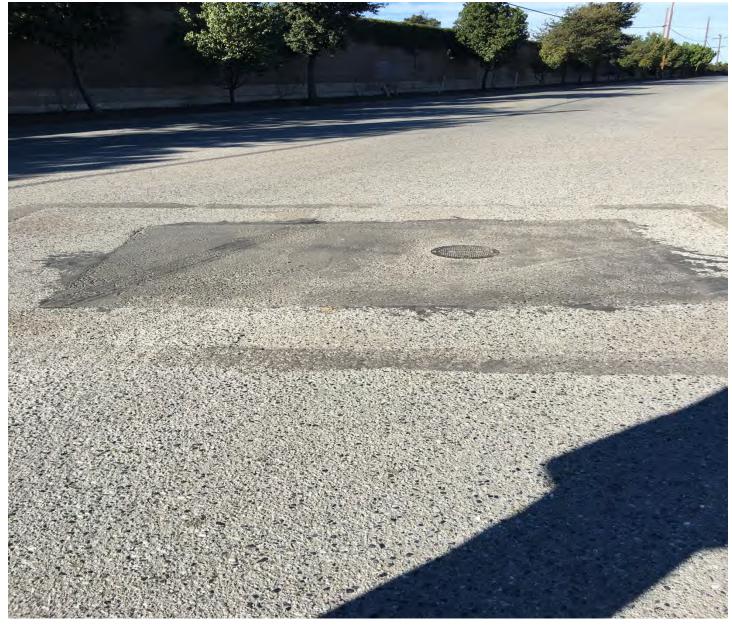
Location: Intersection of Lincoln Street & East Bayshore Road (photographed 12/2/16)

- This is consistent with a valve repair
- There are no markings from USA (811) around the excavation site
- No encroachment permits were found in City records
- No inspections were conducted by City staff
- Appears to be an outer and inner excavation (2 different excavations)
- The replacement asphalt is not in accordance with City standards

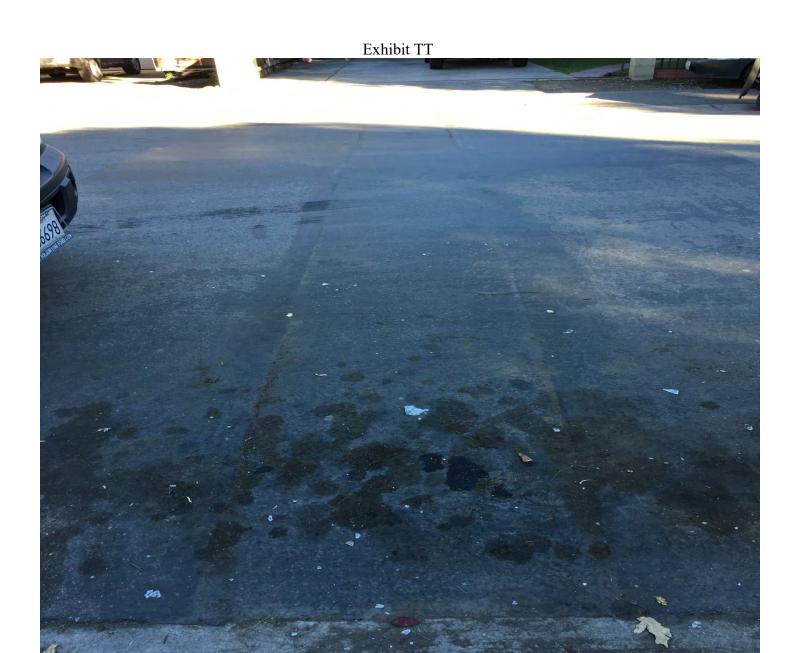
Location: 432 Bell Street (photographed 12/2/16)

d C i
Violations:	The above picture depicts an excavation along the width of Bell Street.
	 This is consistent with a lateral repair
	 There are no markings from USA (811) around the excavation site
	 No encroachment permits were found in City records
	 No inspections were conducted by City staff
	 The replacement asphalt is not in accordance with City standards

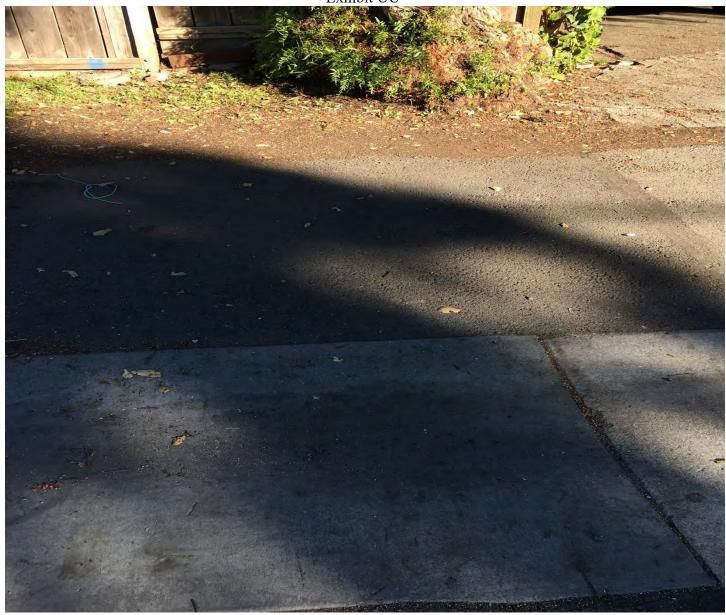
Location: 419 Bell Street (photographed 12/2/16)

Location. 417 Ben Street (photographed 12/2/10)
Violations:	The above picture depicts an excavation.
	 This is consistent with a main repair
	• There are no markings from USA (811) around the excavation site
	 No encroachment permits were found in City records
	 No inspections were conducted by City staff
	The replacement asphalt is not in accordance with City standards

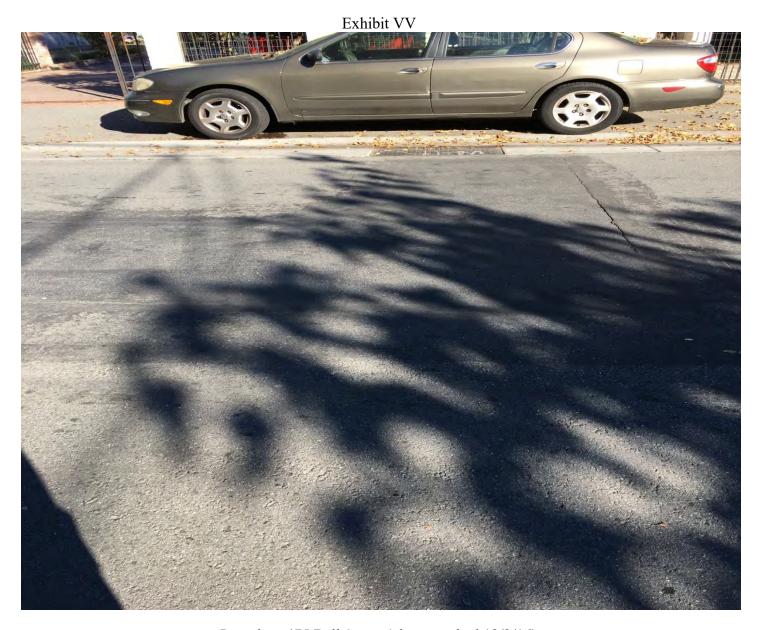
Location: 475 Bell Street (photographed 12/2/16)

Edeation: 175 Ben Street (photographed 12/2/10)
Violations:	The above picture depicts an excavation.
	This is consistent with a main repair
	• There are no markings from USA (811) around the excavation site
	 No encroachment permits were found in City records
	 No inspections were conducted by City staff
	The replacement asphalt is not in accordance with City standards and not
	"flush"

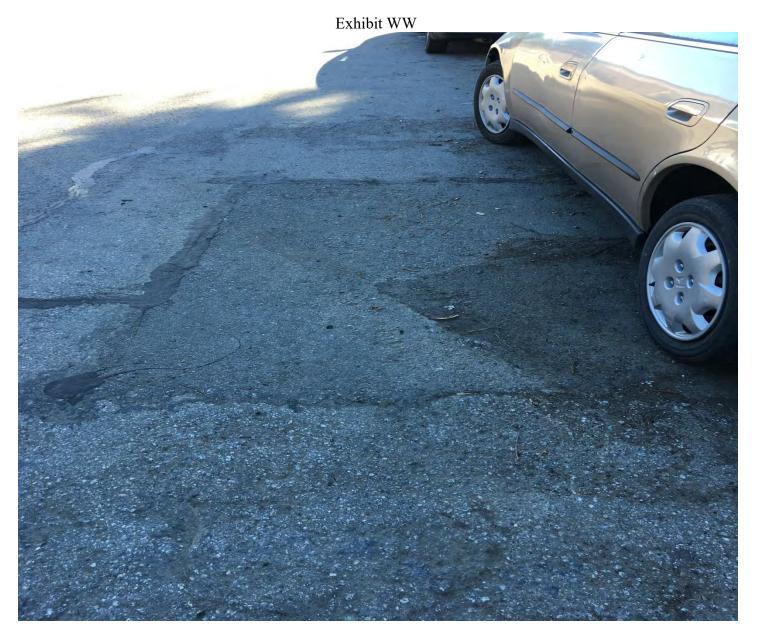
Location: West Bayshore & Donohoe Street (photographed 12/2/16)

- This is consistent with a main repair
- There are no markings from USA (811) around the excavation site
- No encroachment permits were found in City records
- No inspections were conducted by City staff
- The replacement asphalt is not in accordance with City standards
- Appears to be multiple excavations (2 different excavations)
- The cracking asphalt around the excavation is consistent with poor compaction of the backfill material
- Cracking beside the work area shows the soil is failing adjacent to the area of repair due to improper work

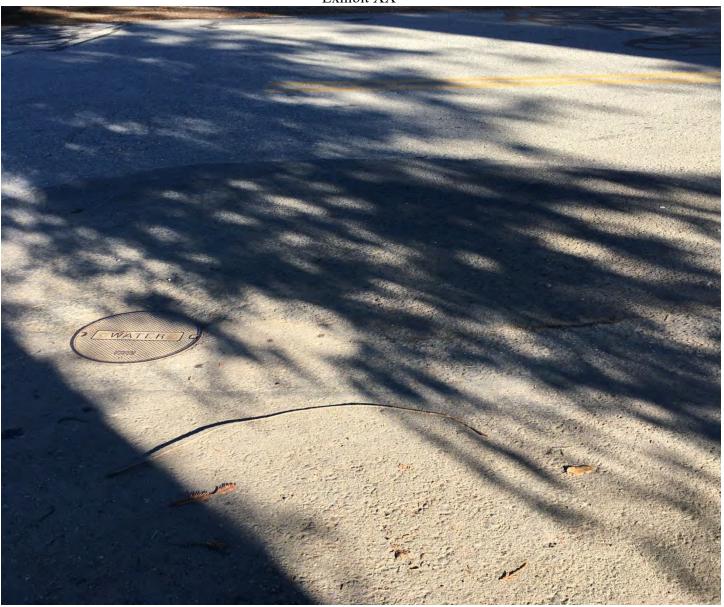
Location: 248 Green Street (photographed 12/2/16)

Violations:	The above picture depicts an excavation.	
	This is consistent with a main repair	
	• There are no markings from USA (811) around the excavation site	
	 No encroachment permits were found in City records 	
	 No inspections were conducted by City staff 	
	The replacement asphalt is not in accordance with City standards

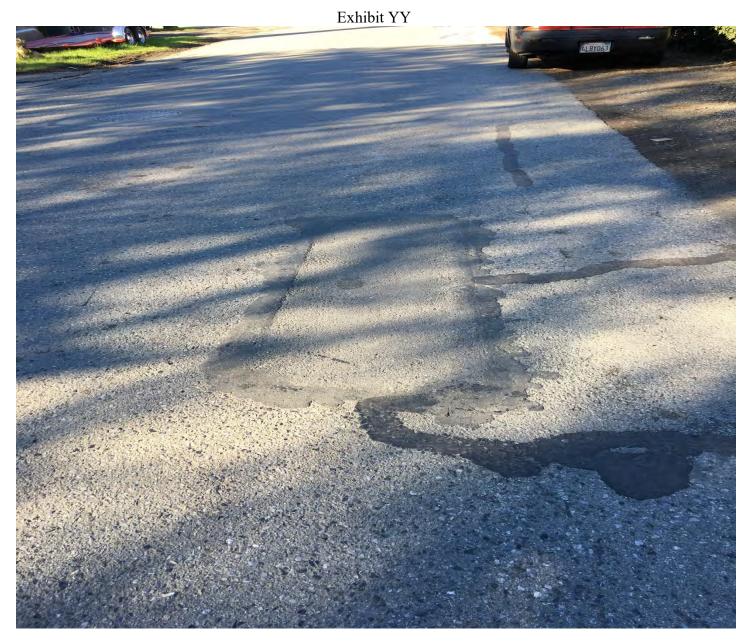
Location: 175 Green Street (photographed 12/2/16)

Violations:	The above picture depicts an excavation.
	This is consistent with a main repair
	• There are no markings from USA (811) around the excavation site
	No encroachment permits were found in City records
	 No inspections were conducted by City staff
	The replacement asphalt is not in accordance with City standards and not
	"flush"

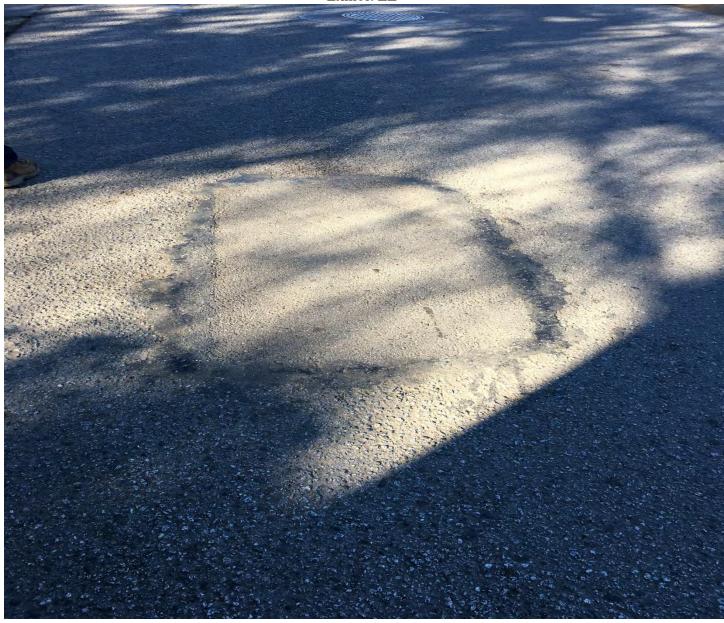
Location: 175 Green Street (photographed 12/2/16)

Eocation: 175 Green Street (photographed 12/2/10)	
Violations:	The above picture depicts an excavation.	
	This is consistent with a main repair	
	 There are no markings from USA (811) around the excavation site 	
	 No encroachment permits were found in City records 	
	 No inspections were conducted by City staff 	
	 The replacement asphalt is not in accordance with City standards

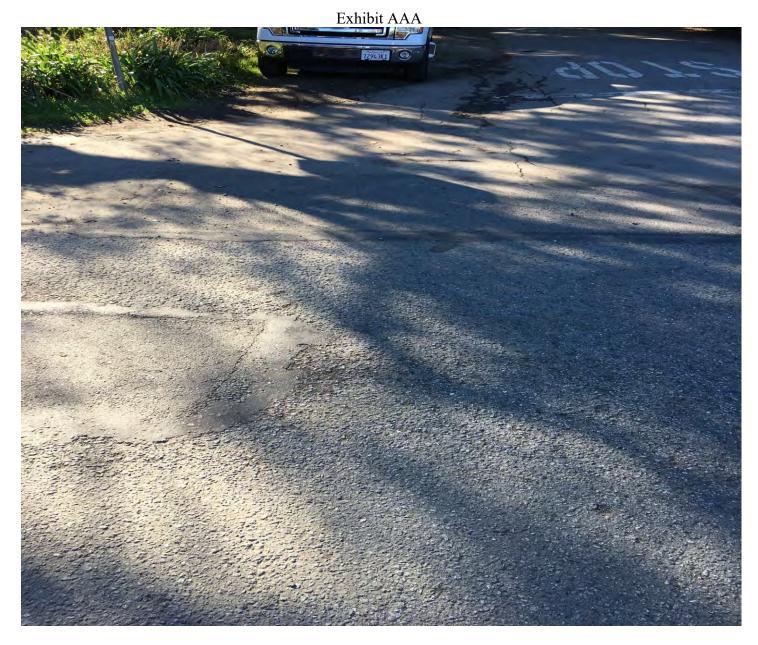
Location: Intersection of Green Street & Ralmar Avenue (photographed 12/2/16)

Violations:	The above picture depicts an excavation.
	This is consistent with a main repair
	• There are no markings from USA (811) around the excavation site
	No encroachment permits were found in City records
	 No inspections were conducted by City staff
	The replacement asphalt is not in accordance with City standards

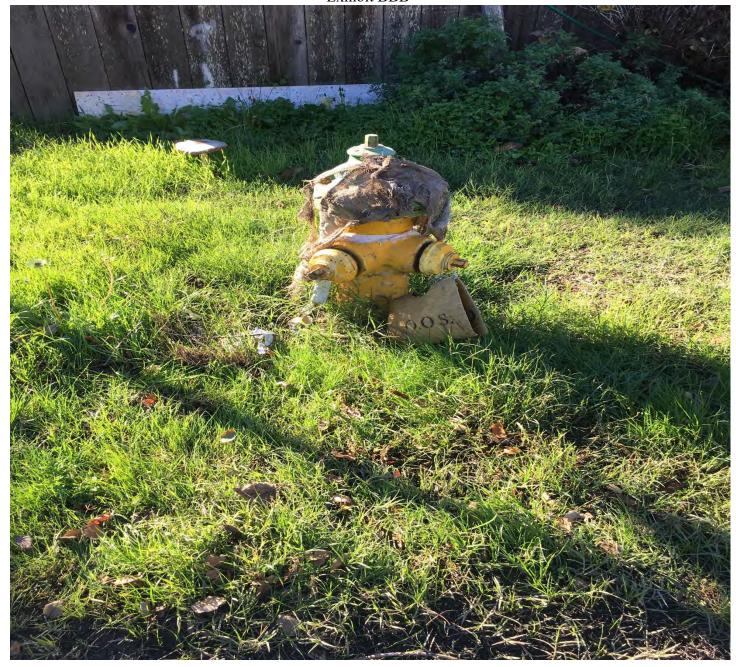
Location: Intersection of Green Street & Ralmar Avenue (photographed 12/2/16)
Witness: Kevin Lewis (Engineering Division)

Violations:	Site of water theft
	Illegal excavation of hydrant not pertaining to PAPMWC
	No permit from City to conduct work
	No USA (811) markings
	Reinstalled an unapproved hydrant
	(see witness narrative labeled Attachment # 2)

January 2014, I Kevin Lewis, Lead Operator for American Water Services at the time, observed an illegal water utility (fire hydrant) excavation during morning routine system maintenance at the corner of Green Street & Ralmar Avenue. This was an illegal utility excavation performed by Palo Alto Park Mutual Water Company.

The underground reconstruction was improperly completed and is now without proper restraints. The fire hydrant that once existed is no longer there, replaced with another dry barrel hydrant which does not belong to the City of East Palo Alto. The fire hydrant remains un-operational due to the closing of the freeway crossing. However, after the reconstruction the Menlo Park Fire Department was notified that the hydrant was un-operational. Other fire hydrants in close proximity were identified for emergency purposes. The original Clow Fire Hydrant has not been returned and the meter readings confirmed that the water usage and billing were correct according to American Water Services. The Billing was an excessive \$7,000.

I instructed them to rebuild the water main spools and reinstall the fire hydrant, and to repair the City Right Of Way that was excavated. I monitored the excavated site approximately one month before rebuild/reconstruction of the excavation site.

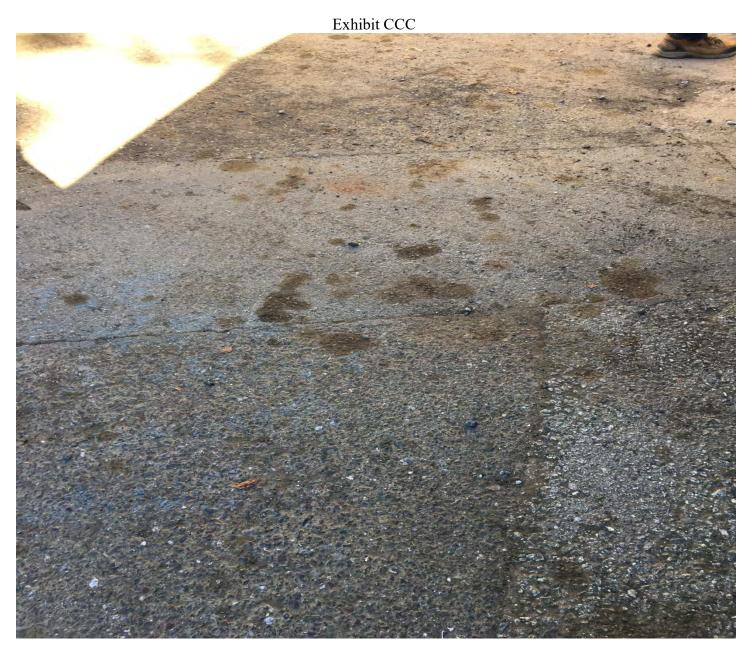
Location: 2032 Poplar Avenue (photographed 12/2/16)

Violations:	The above picture depicts an excavation.	
	This is consistent with a main repair	
	• There are no markings from USA (811) around the excavation site	
	No encroachment permits were found in City records	
	No inspections were conducted by City staff	
	The replacement asphalt is not in accordance with City standards

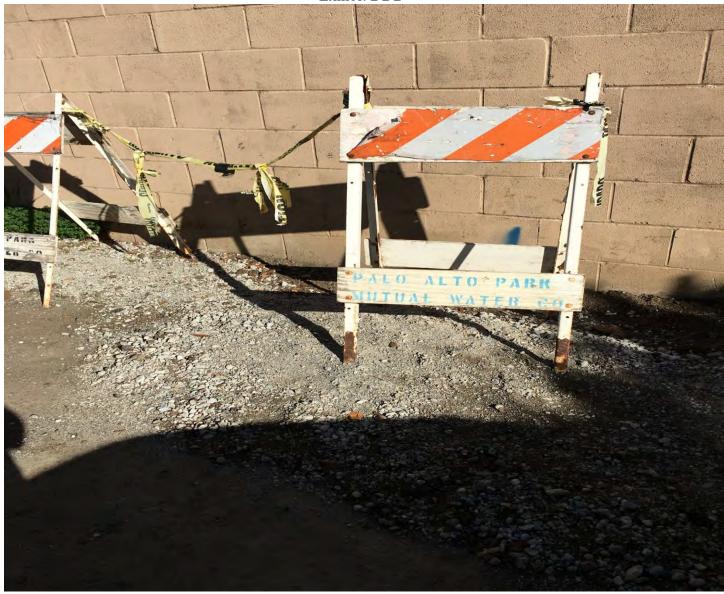
Location: 2032 Poplar Avenue (photographed 12/2/16)

Violations:	Illegal excavation
	Work without a City permit
	No inspections conducted by City staff
	No USA (811) markings
	Equipment left on site
