City of East Palo Alto

Investigation into Palo Alto Park Mutual Water Company

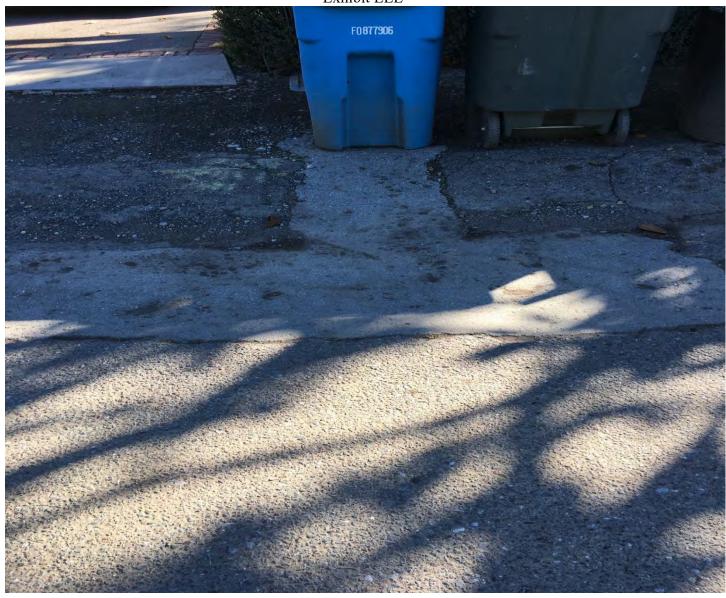
Location: 2032 Poplar Avenue (photographed 12/2/16)

- This is consistent with a lateral repair
- There are no markings from USA (811) around the excavation site
- No encroachment permits were found in City records
- No inspections were conducted by City staff
- The replacement asphalt is not in accordance with City standards
- The cracking asphalt around the excavation is consistent with poor compaction of the backfill material
- Cracking beside the work area shows the soil is failing adjacent to the area of repair due to improper work

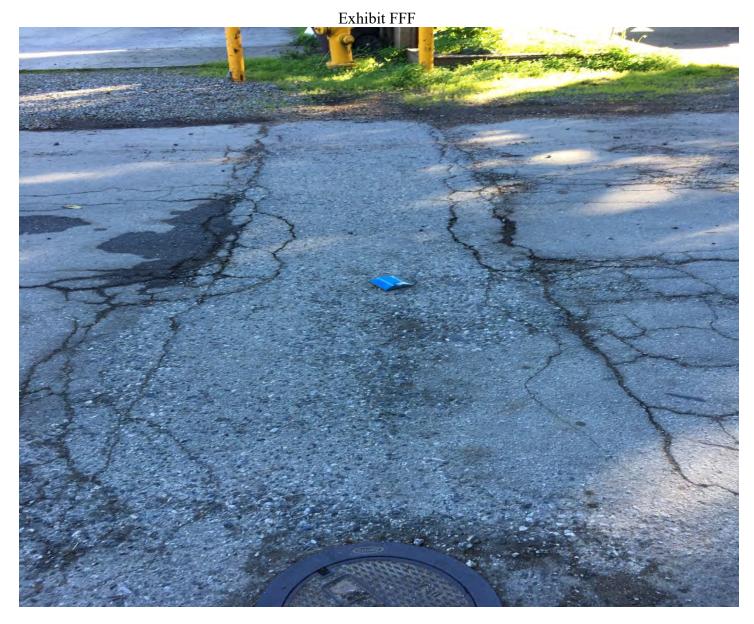
Location: 2050 Ralmar Avenue (photographed 12/2/16) The above picture depicts an excavation.

Education: 2000 Rammar 11 Onde (priotographed 12/2/10)
Violations:	The above picture depicts an excavation.
	This is consistent with a hydrant lateral repair
	• There are no markings from USA (811) around the excavation site
	 No encroachment permits were found in City records
	 No inspections were conducted by City staff
	The replacement asphalt is not in accordance with City standards
	 The cracking asphalt around the excavation is consistent with poor compaction of the backfill material
	Cracking beside the work area shows the soil is failing adjacent to the area of repair due to improper work

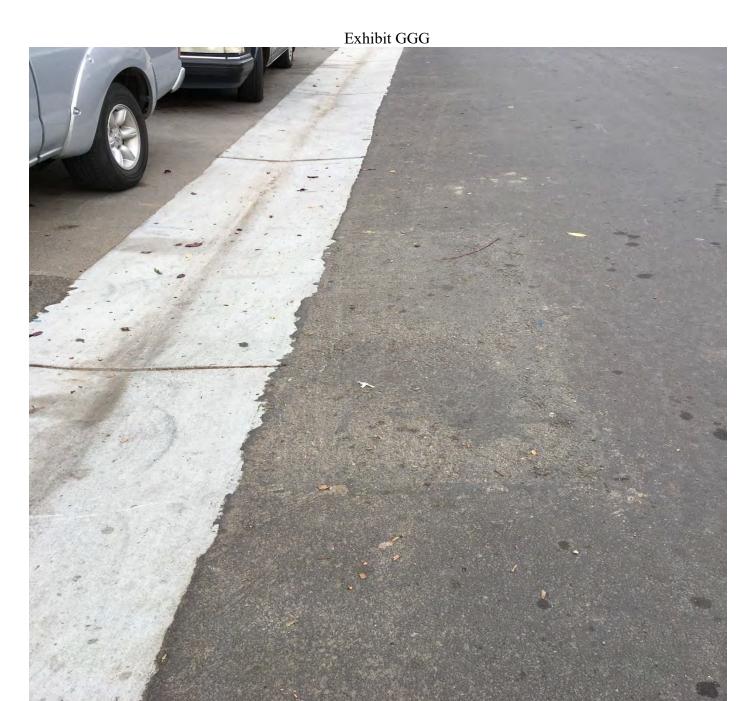
Location: 2143Dumbarton Avenue (photographed 12/5/16)

Location: 2145Dumbarton Avenue (photographed 12/5/16)
Violations:	The above picture depicts an excavation.
	This is consistent with a main repair
	 There are no markings from USA (811) around the excavation site
	 No encroachment permits were issued in City records
	 No inspections were conducted by City staff
	The replacement asphalt is not in accordance with City standards

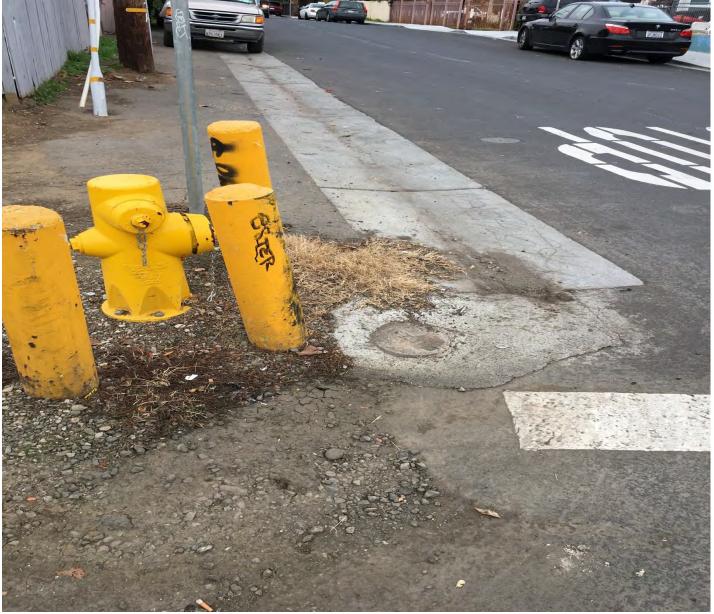
Location: Intersection of Oakwood Avenue & East Bayshore Road (photographed 12/5/16)

- This is consistent with a main repair
- New valve for hydrant placed without a permit
- Hydrant it not the appropriate height
- There are no markings from USA (811) around the excavation site
- No encroachment permits were found in City records
- No inspections were conducted by City staff
- The replacement asphalt is not in accordance with City standards

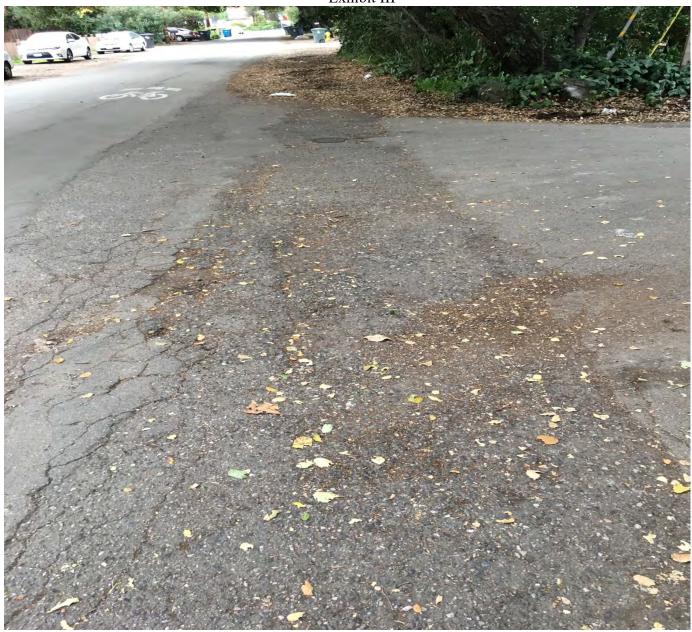
Location: Intersection of Donohoe Street & Ralmar Avenue (photographed 12/5/16)

- This is consistent with a main repair
- There are no markings from USA (811) around the excavation site
- No encroachment permits were found in City records
- No inspections were conducted by City staff
- The replacement asphalt is not in accordance with City standards
- The cracking asphalt around the excavation is consistent with poor compaction of the backfill material
- Cracking beside the work area shows the soil is failing adjacent to the area of repair due to improper work

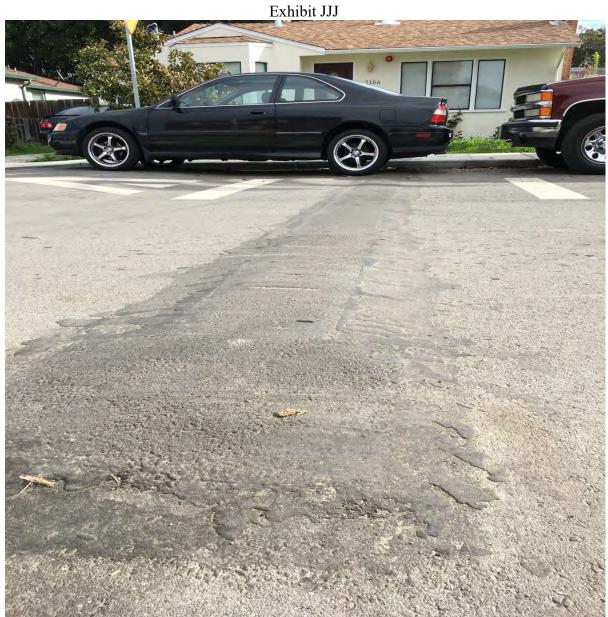
Location: 2166 Poplar Avenue (photographed on 12/13/16)

- This is consistent with a main repair
- There are no markings from USA (811) around the excavation site
- No encroachment permits were found in City records
- No inspections were conducted by City staff
- The replacement asphalt is not in accordance with City standards and not "flush"

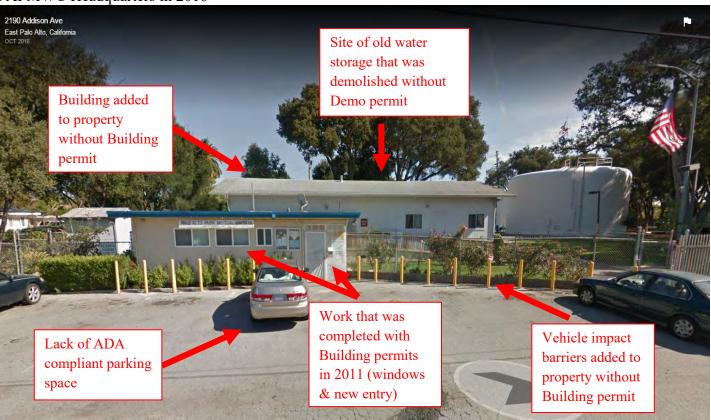
PAPMWC Headquarters in 2016

PAPMWC had a facilities upgrade shortly after the 1989 Loma Prieta Earthquake. They followed the formal permitting process with the City to repair the damages their system had sustained. Prior to construction, they applied for a variance which they were awarded with the condition that they obtain a Building Permit. Needless to say, a Building permit was not issued. The damaged tanks were demolished and an additional building was built on the property behind the main office without a Building permit. PAPMWC is aware of the process and requirements to make changes to their buildings but have failed to complete that process (Ms. Loudd was the manager at this point). PAPMWC has also installed vehicle impact barriers in their parking lot without a Building permit. Encroachment permits are not the only permits they refuse to obtain from the City. The following photographs illustrate were PAPMWC have made changes on their headquarters.
